GUILDFORD & MERRYLANDS

MURAL PROJECTS

GUILDFORD TRAIN STATION TUNNEL MURAL

PUBLIC ART PLACE ANALYSIS

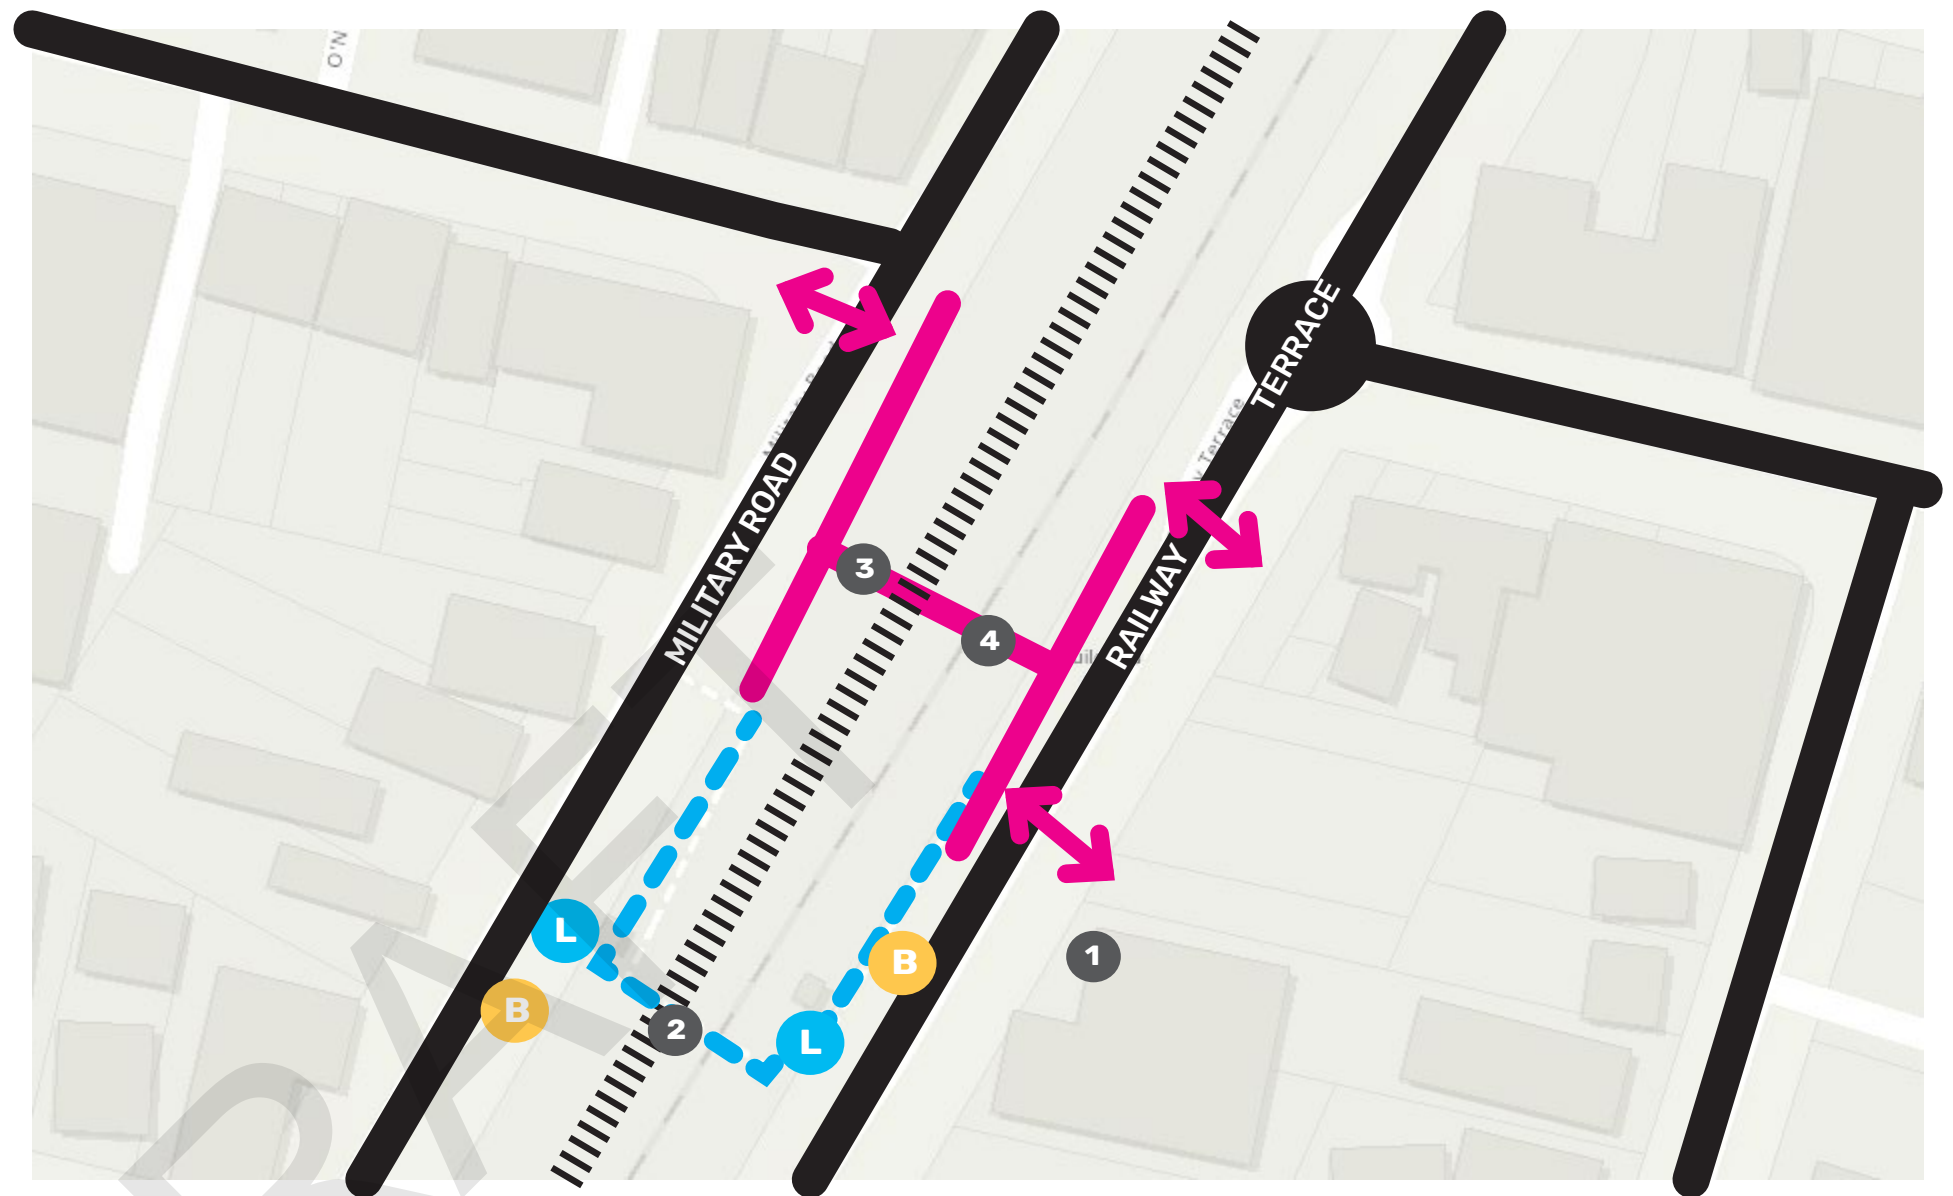
- 1** Shop top housing above retail overlooks the station and the entry to the tunnel. There are limited views into the tunnel from units due to the roof over the ramp and the surrounding landscape.
- 2** No views down into tunnel ramps from overhead bridge. Obstructed by trees and roof structure.
- 3** The tunnel ramps up towards exit ramps.
- 4** Guildford is a longer tunnel than Merrylands and has poor natural light.
- L** Lifts are located on both sides of the rail line, away from the tunnel and ramps.
- B** Bus stops are located away from the tunnels and ramps.

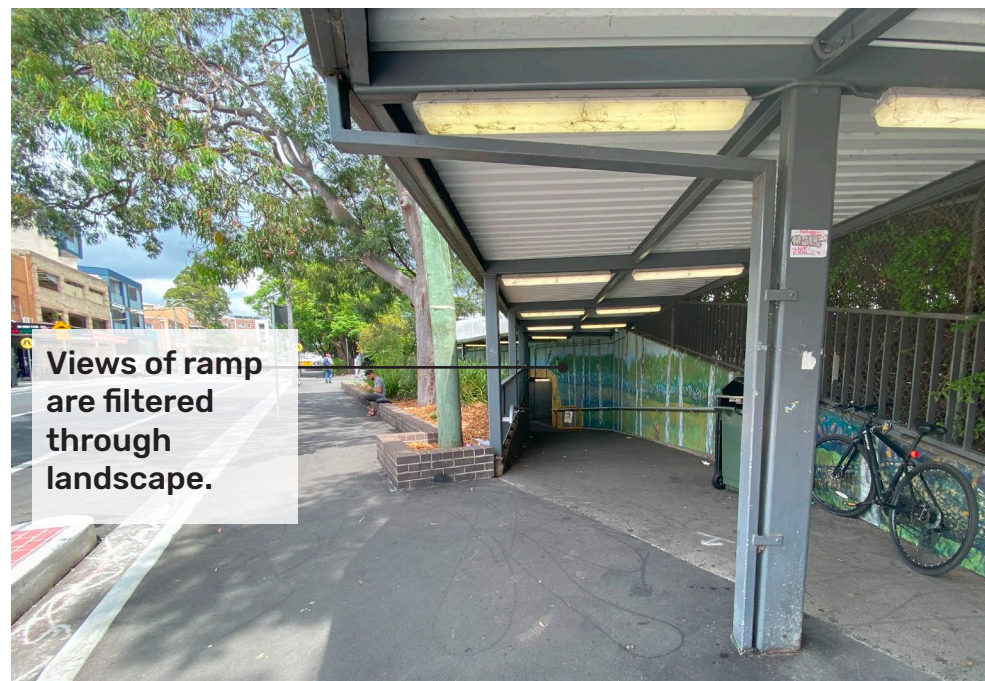
Entry to the tunnel from Railway Terrace on the eastern side of station. Tunnel entry is darker due to roof structure. Views of ramp and tunnel are filtered through landscaping.

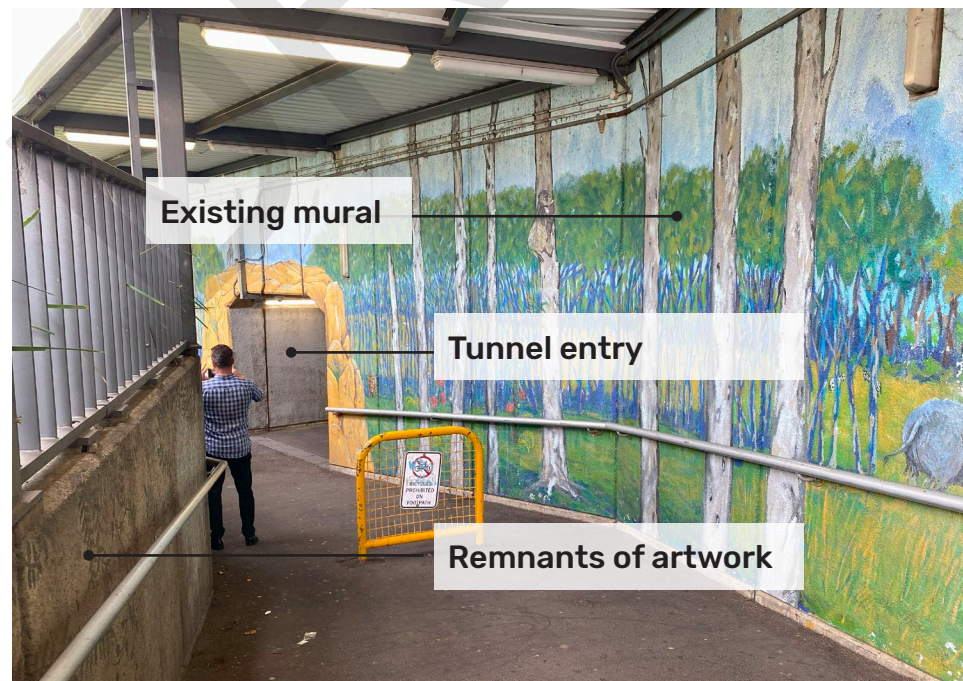
Tunnel entry. Mural is currently on one side of the wall. Some artworks are present on the opposite side yet are faded.

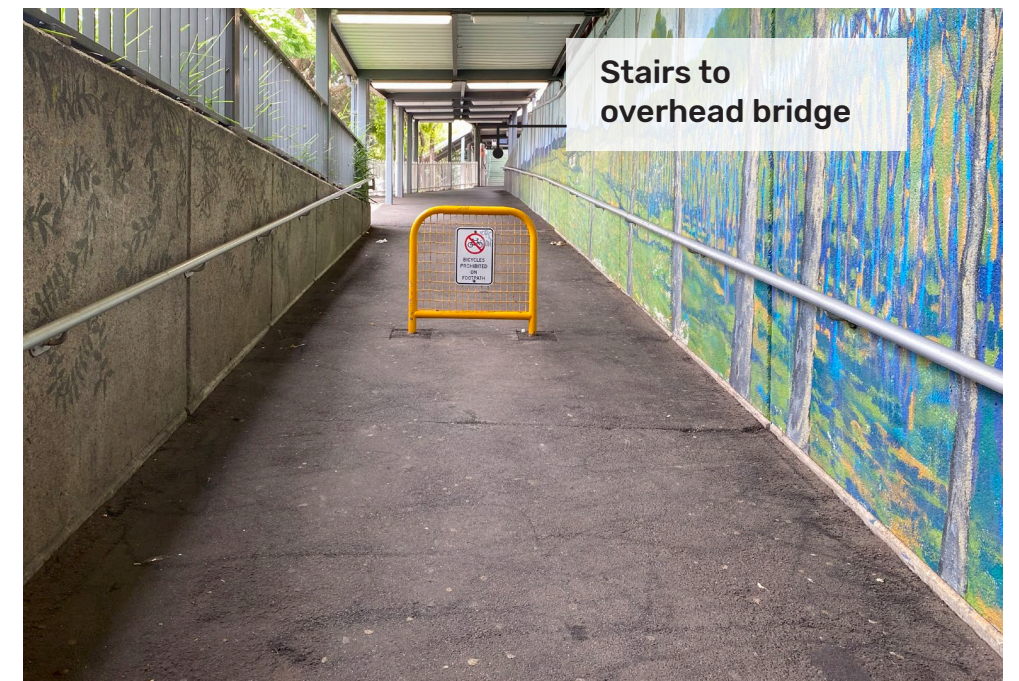
Views up ramp. Beyond is another ramp that leads to the overhead pedestrian bridge and platform access.

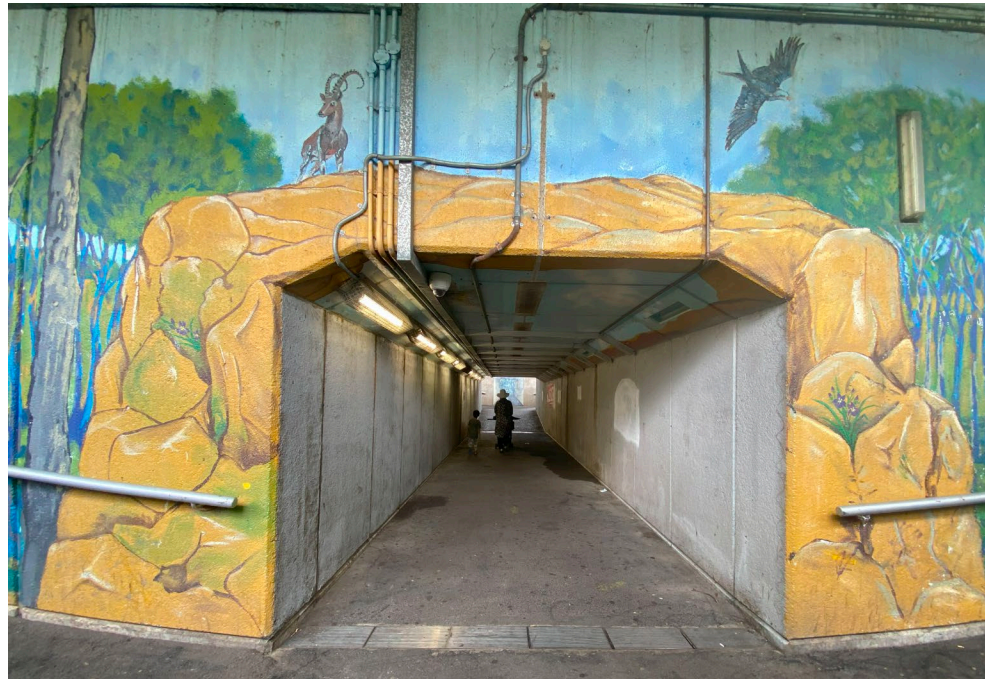
Tunnel looking west. Tunnel is XX long and previous murals, painted on panels have been removed and walls painted white. Roof retains former mural design. Lights have been relocated to the left corners. Some lights are not working resulting in gaps in lighting. Future creative lightning is strongly recommended.

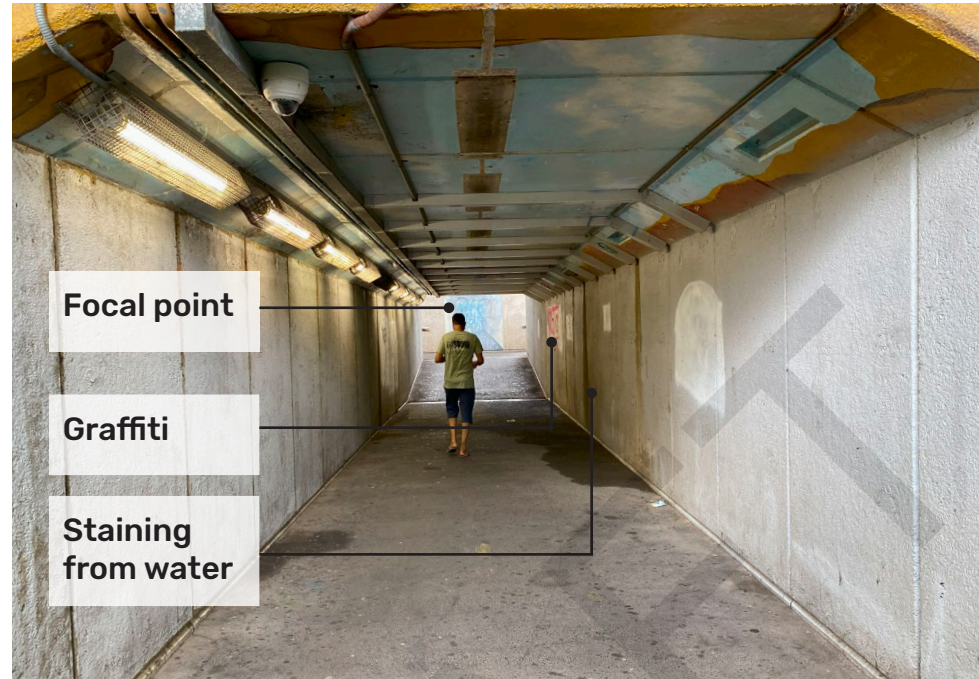
Focal point shifts as the tunnel ramps up. This means its not fully visible in the tunnel. Focal point shows destination and exit and should be distinct from the rest of the tunnel. Graffiti is generally on the side of the tunnel away from the light where there would be more concealment at night.

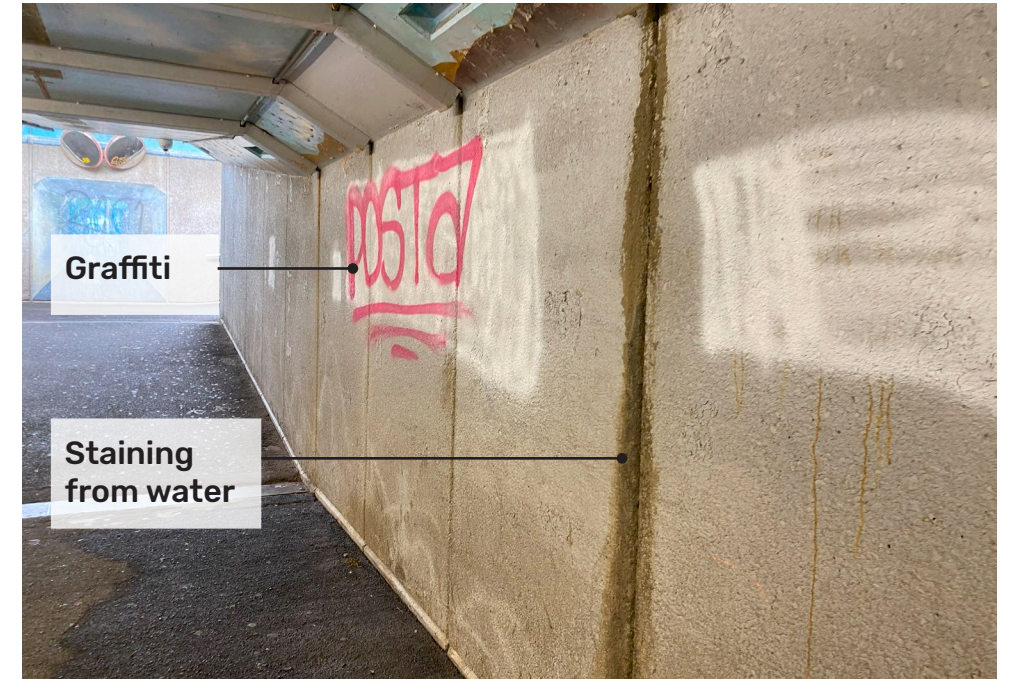
Graffiti painted over and then graffitied again. Staining is visible in this image. The water is not able to be stopped and the stain cannot be removed.

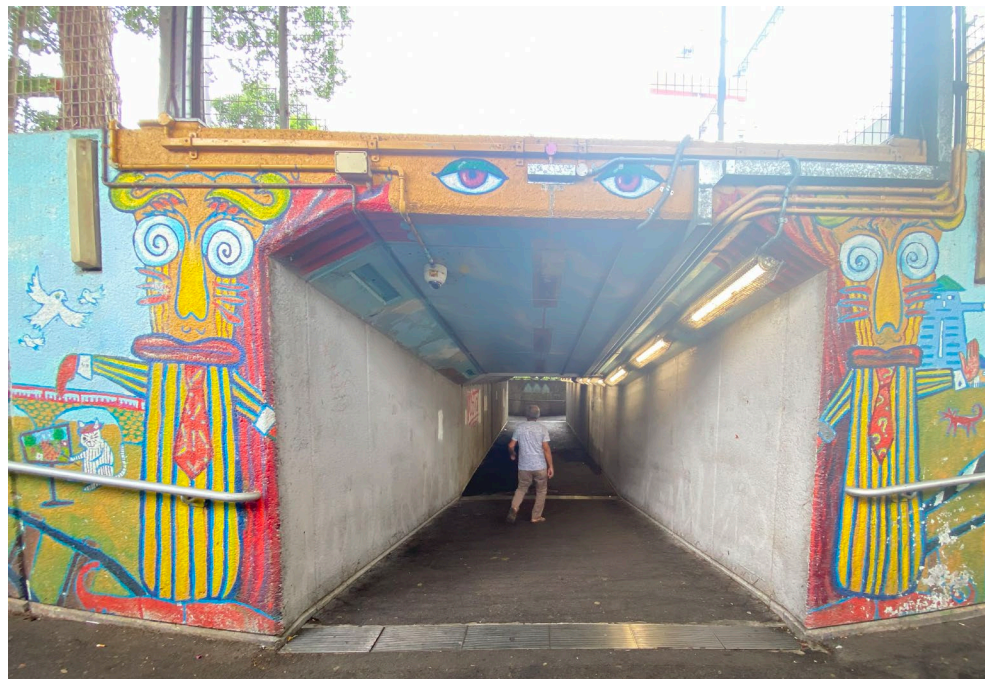
Entry to the tunnel from the eastern side of the rail line looking west. Many of the existing murals have eyes which create the perception of being watched.

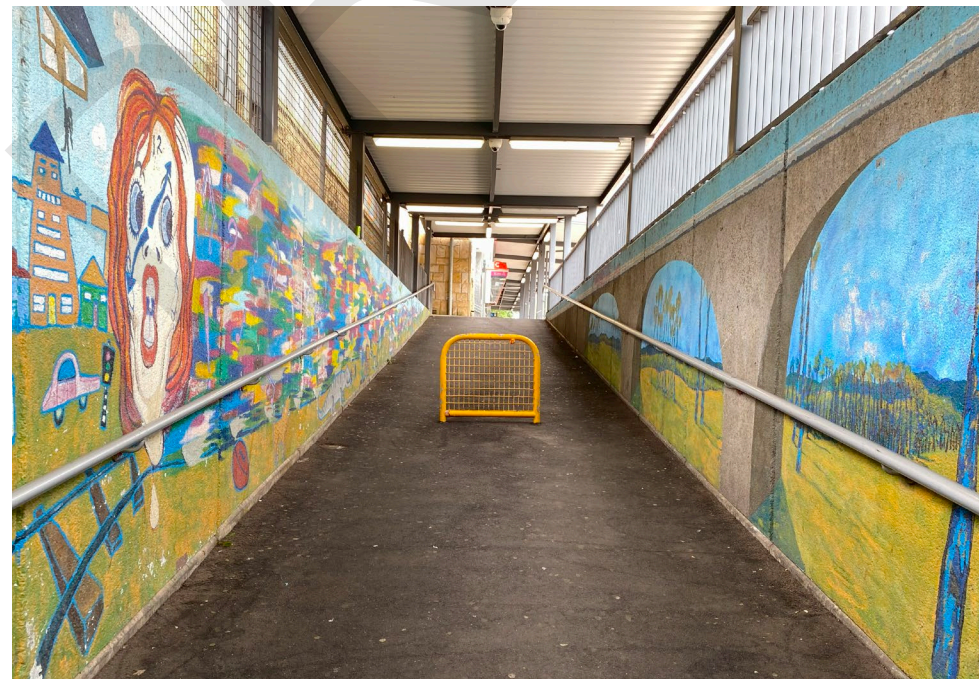
Ramp heading south to the entry to the station, on the western side of the rail line. Mural is on both sides of the ramp. The roof covering the ramp reduces light however, this side of the tunnel is brighter, likely due to the brighter coloured murals and lack of landscape between the footpath and the ramp.

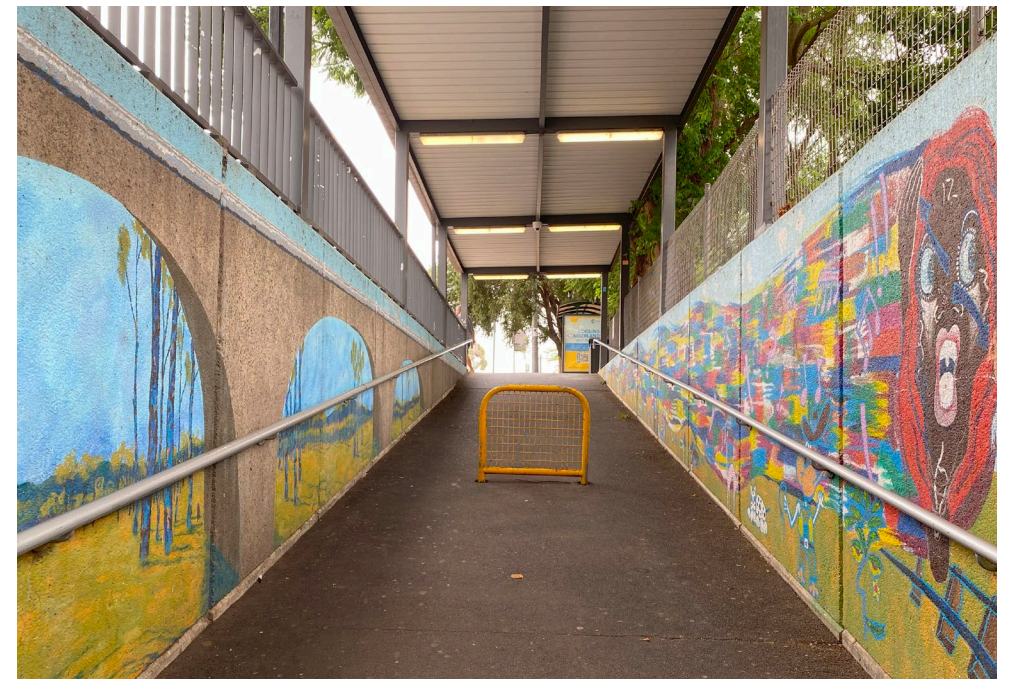
Ramp heading north, on the western side of the rail line. Mural is on both sides of the ramp. The roof covering the ramp reduces lighting, however, this side of the tunnel is brighter likely due to the brighter coloured murals, the lack of landscape between the footpath and the ramp and the western aspect.

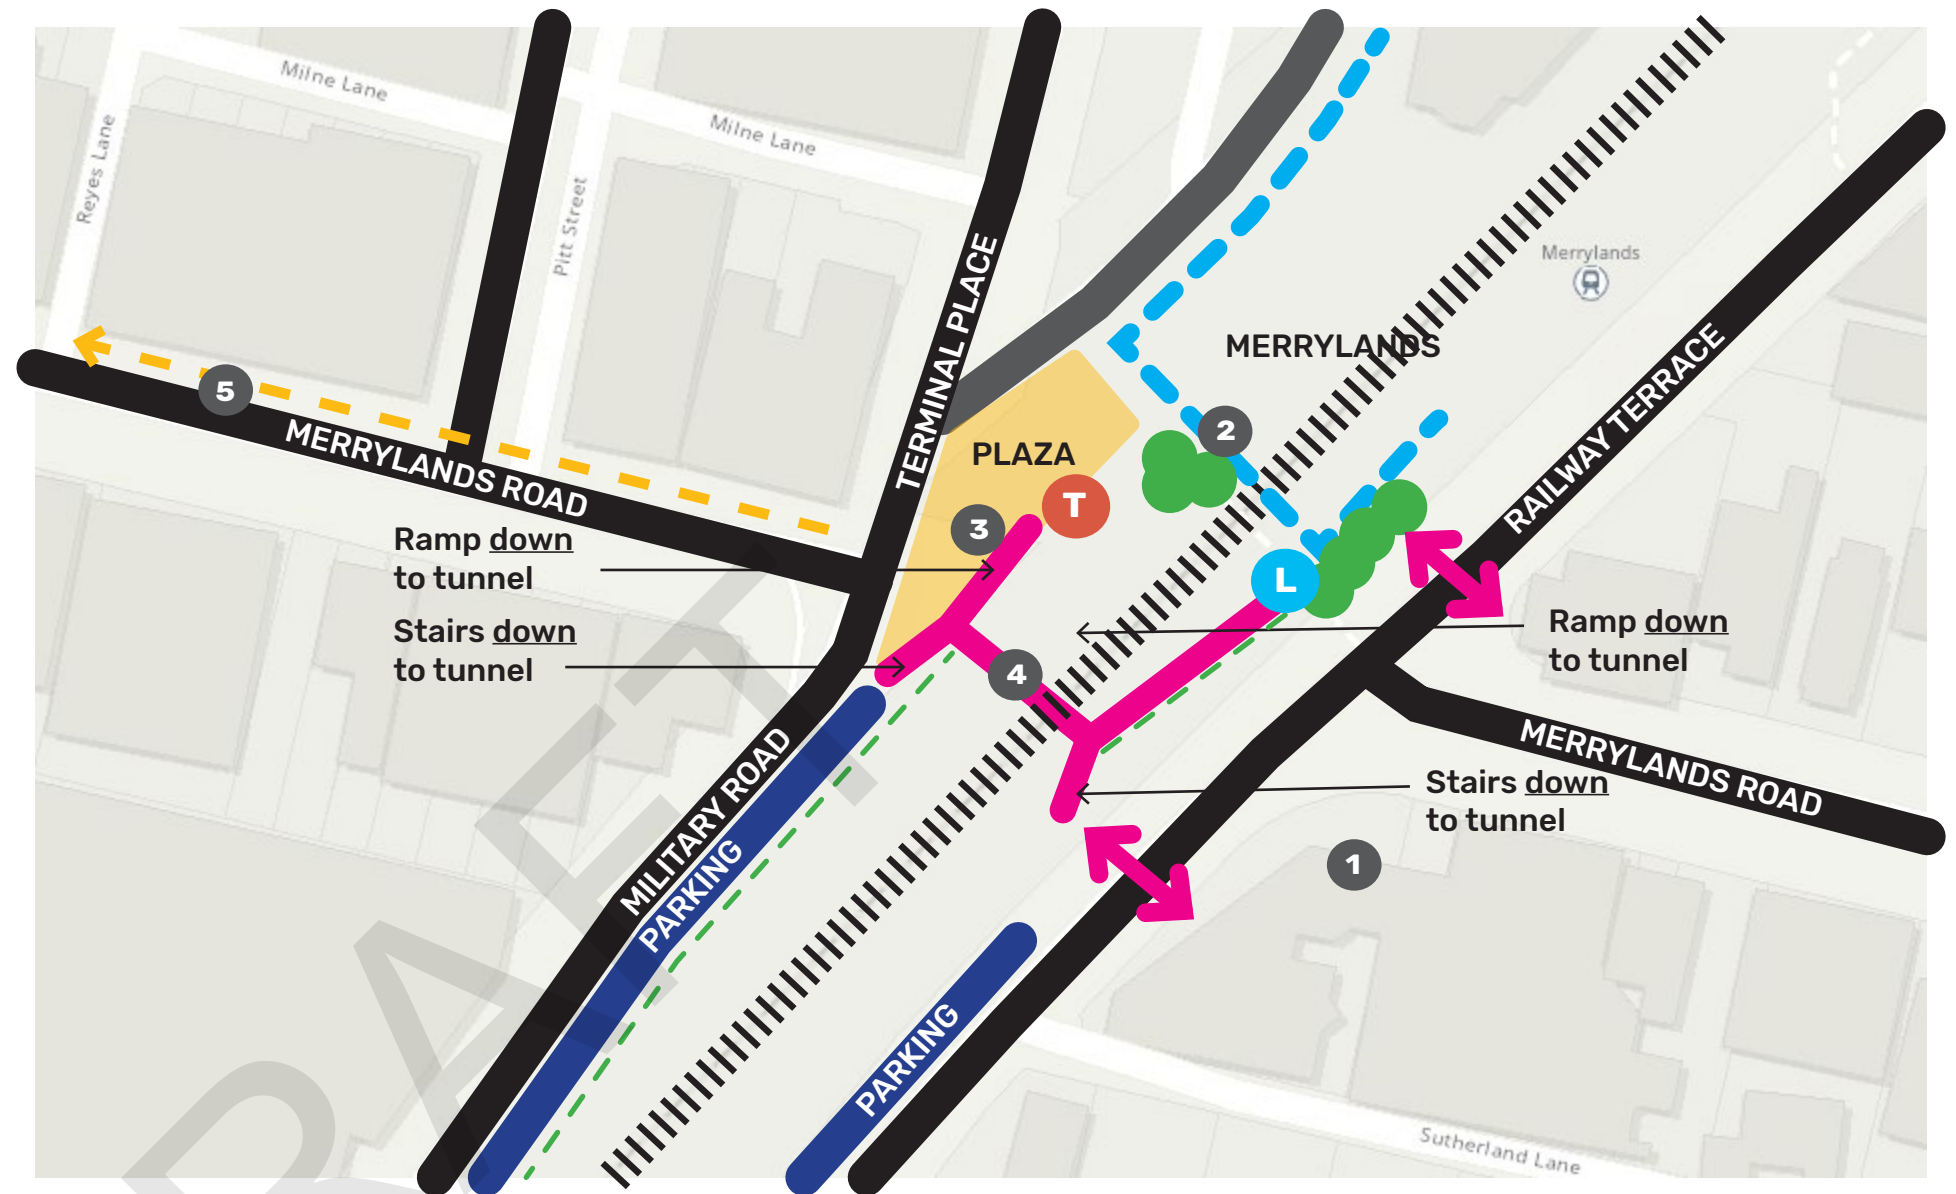
- 1 Shop top housing above retail overlooks the station and the entry to the tunnel. There may be some views into the tunnel from units as it has no obstructing roof, buildings or landscape.
- 2 No views down into tunnel ramps from overhead bridge. Obstructed by trees.
- 3 External light in plaza may illuminate parts of the tunnel but could also exacerbate contrast between light and dark.
- 4 Merrylands is a shorter tunnel than Guildford and has better natural light.
- 5 Main street of Merrylands which leads to the new plaza which links with the shopping centre.
- L Lift is located at the end of the ramp and the artwork will be visible from this location.
- T Public Toilets located at the end of the western ramp. Not operating during site visit.
- - Dilapidated fence needs to be restored to improve the appearance of the area.

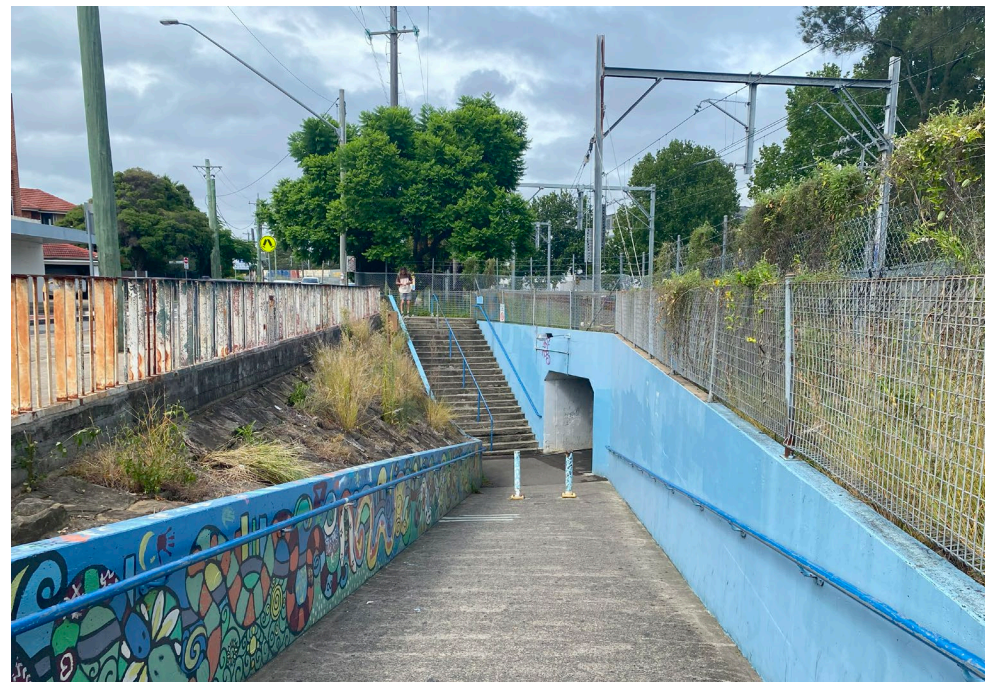
View down the ramp on Railway Terrace looking to the tunnel. Mural on eastern wall. Handrail (blue on east side and green on west side) has been painted and is scratched.

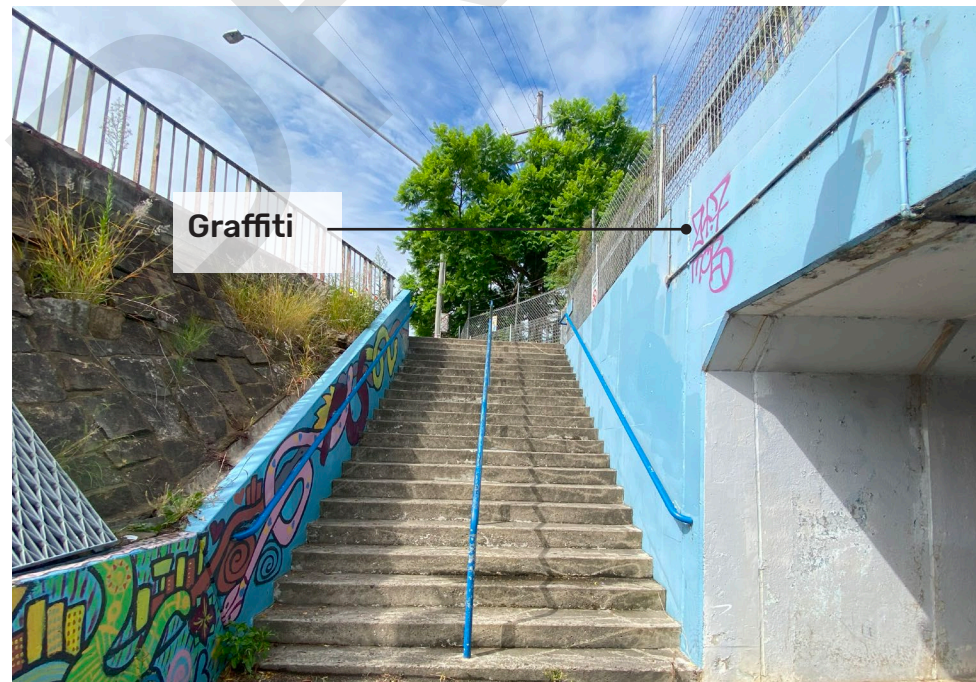
Looking up the stairs that connect to Railway Terrace. Weeds and grass grow in the retaining wall. Graffiti is observed above the tunnel.

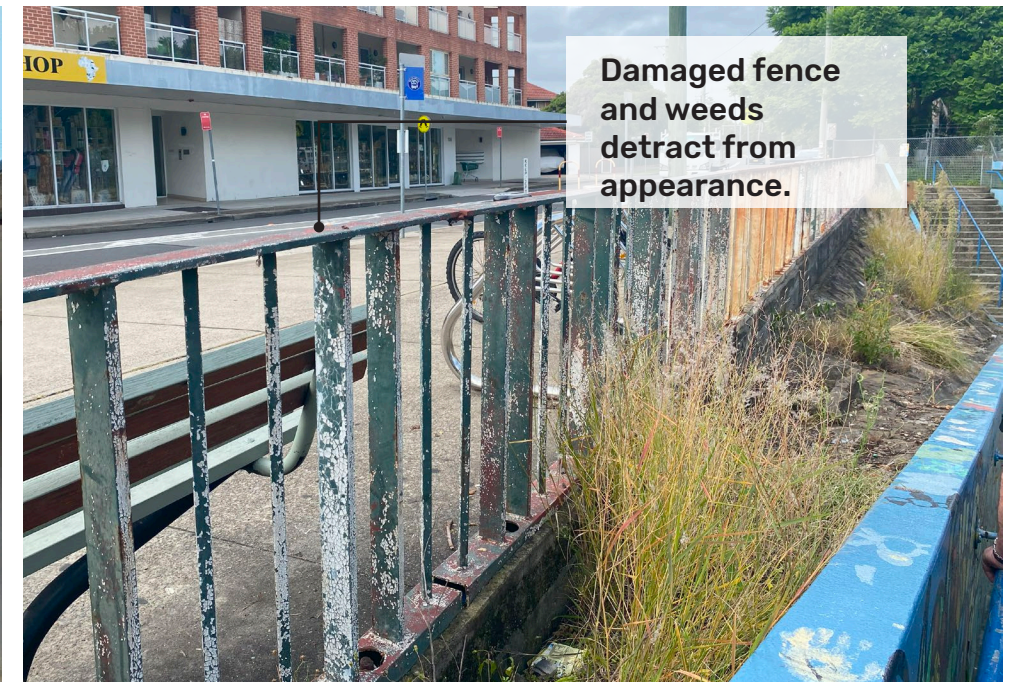
Existing fence separating Railway Terrace from the ramp and stairs. Fence has been painted green and the paint is chipping. Fence is detracting from the areas appearance and needs to be repainted.

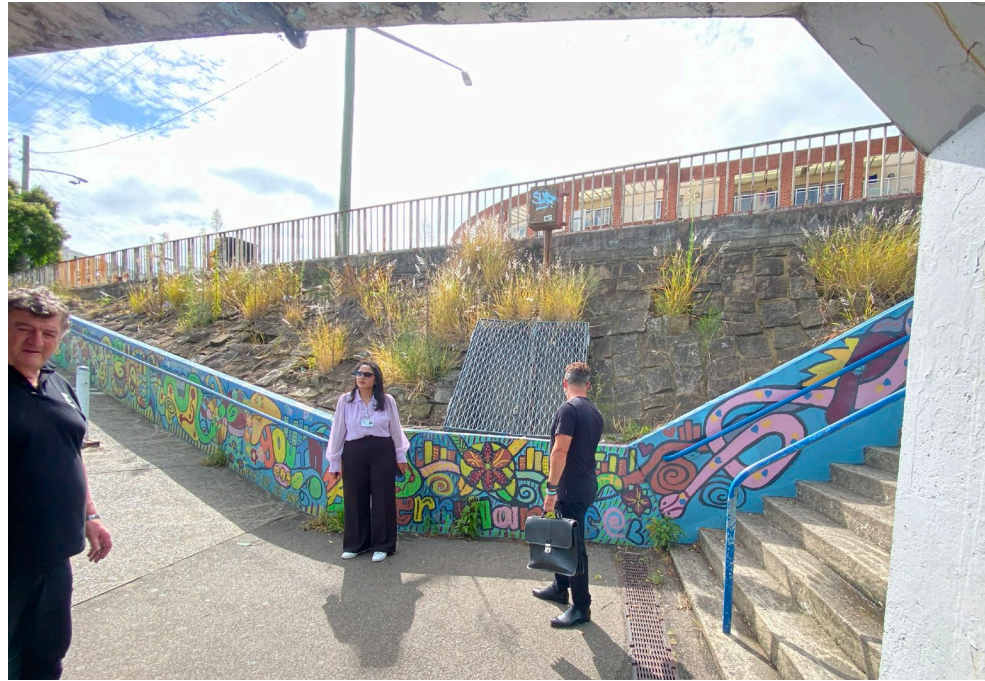
Murals wrap around low wall up ramp and stair. The street is not visible from the tunnel.

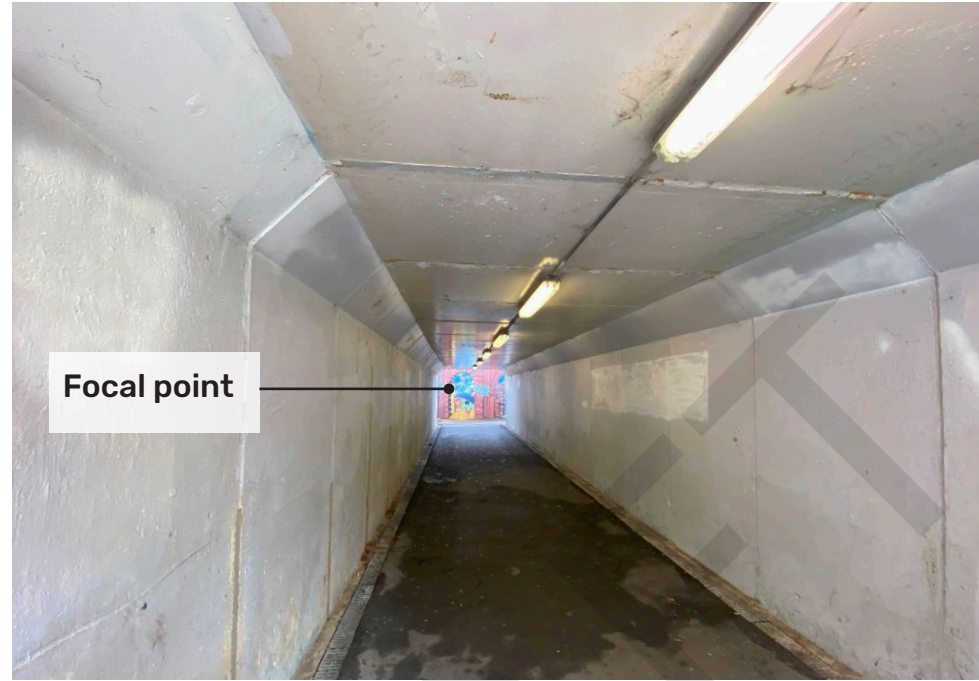
Tunnel is currently painted white which boosts lighting outputs. Any mural will naturally decrease light and needs to be capable of brightening the space. Mural at end is currently highlighting the destination. Maintaining this focal point should be considered in the tunnel mural design.

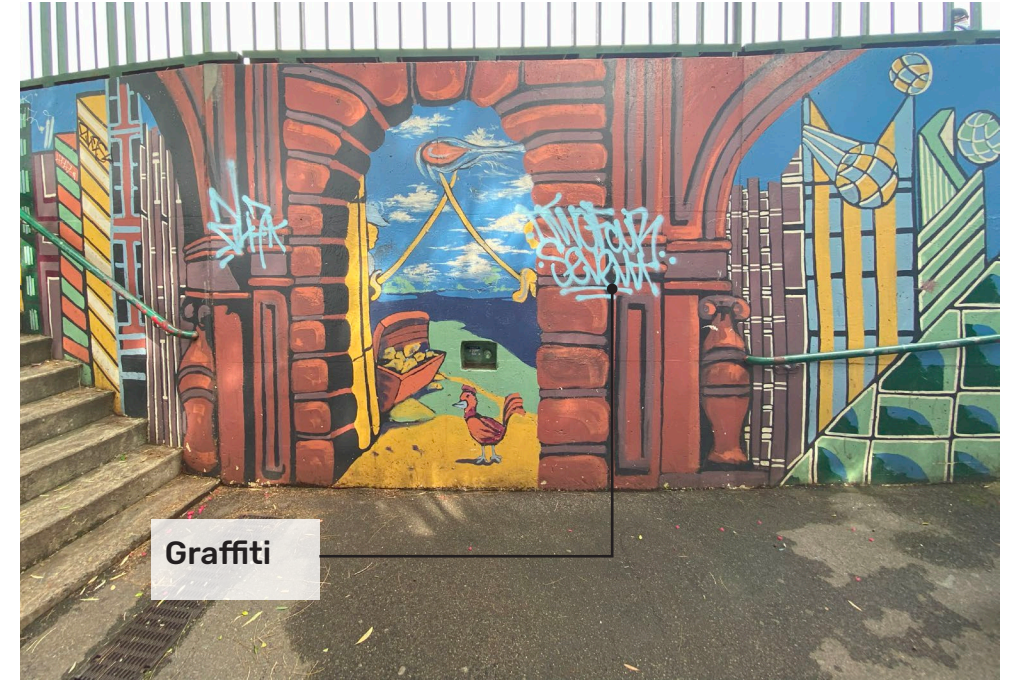
Artwork at the western end of the tunnel between stairs and ramp. Graffiti is observed on these murals.

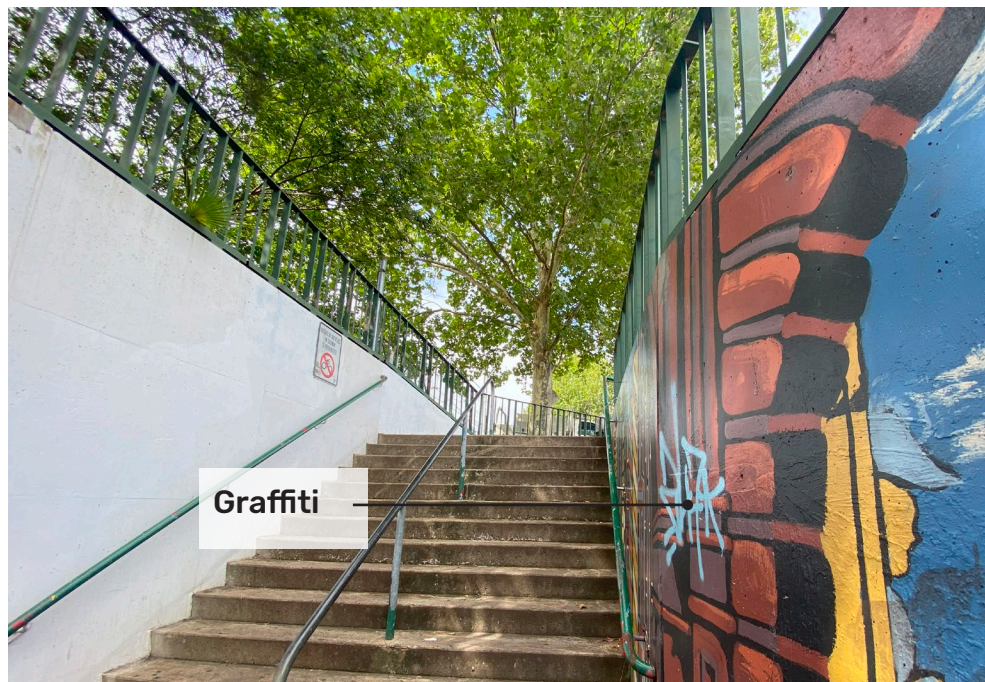
View up stairs on the western side of the rail corridor. Existing mural is limited to one wall. It is possible the mural has been painted over in the past.

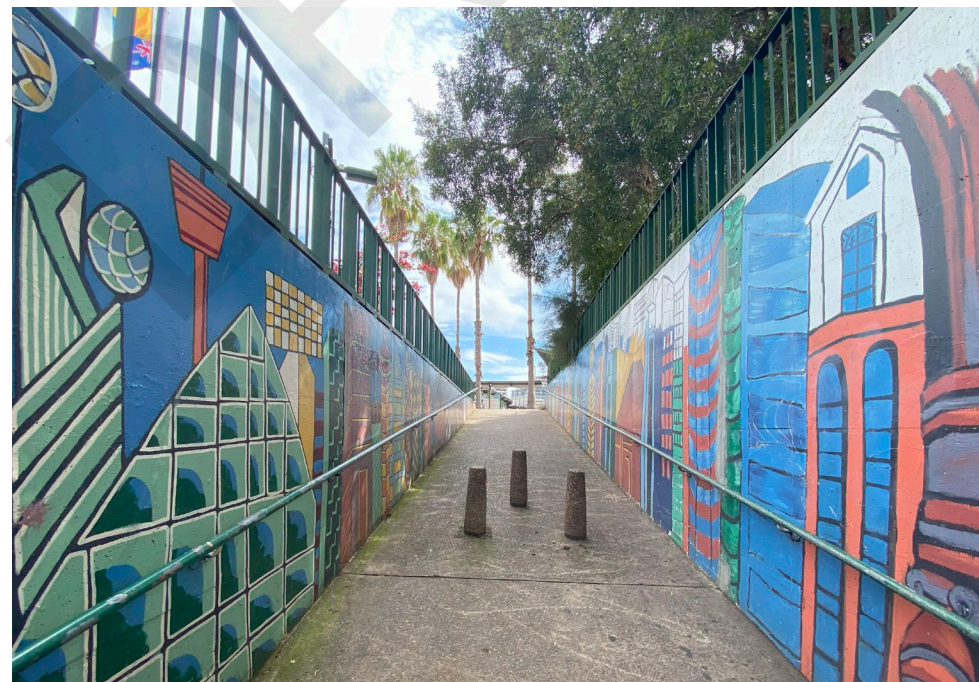
View up ramp towards plaza, train station and toilets. Mural is on both sides of the ramp, unlike the stairs.

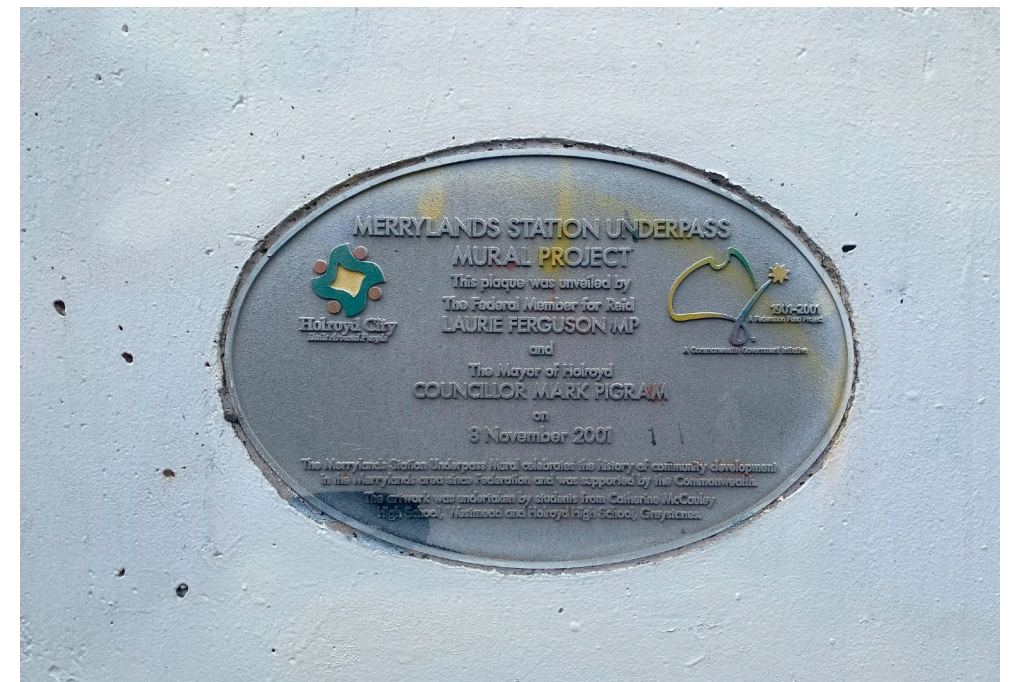
Existing attribution for the mural. This plaque will need to be replaced or updated.
