Land Use Suitability Review

Lot 12 DP 1166540
300 Manchester Road
Auburn NSW 2144

Payce Consolidated Limited

July 2015

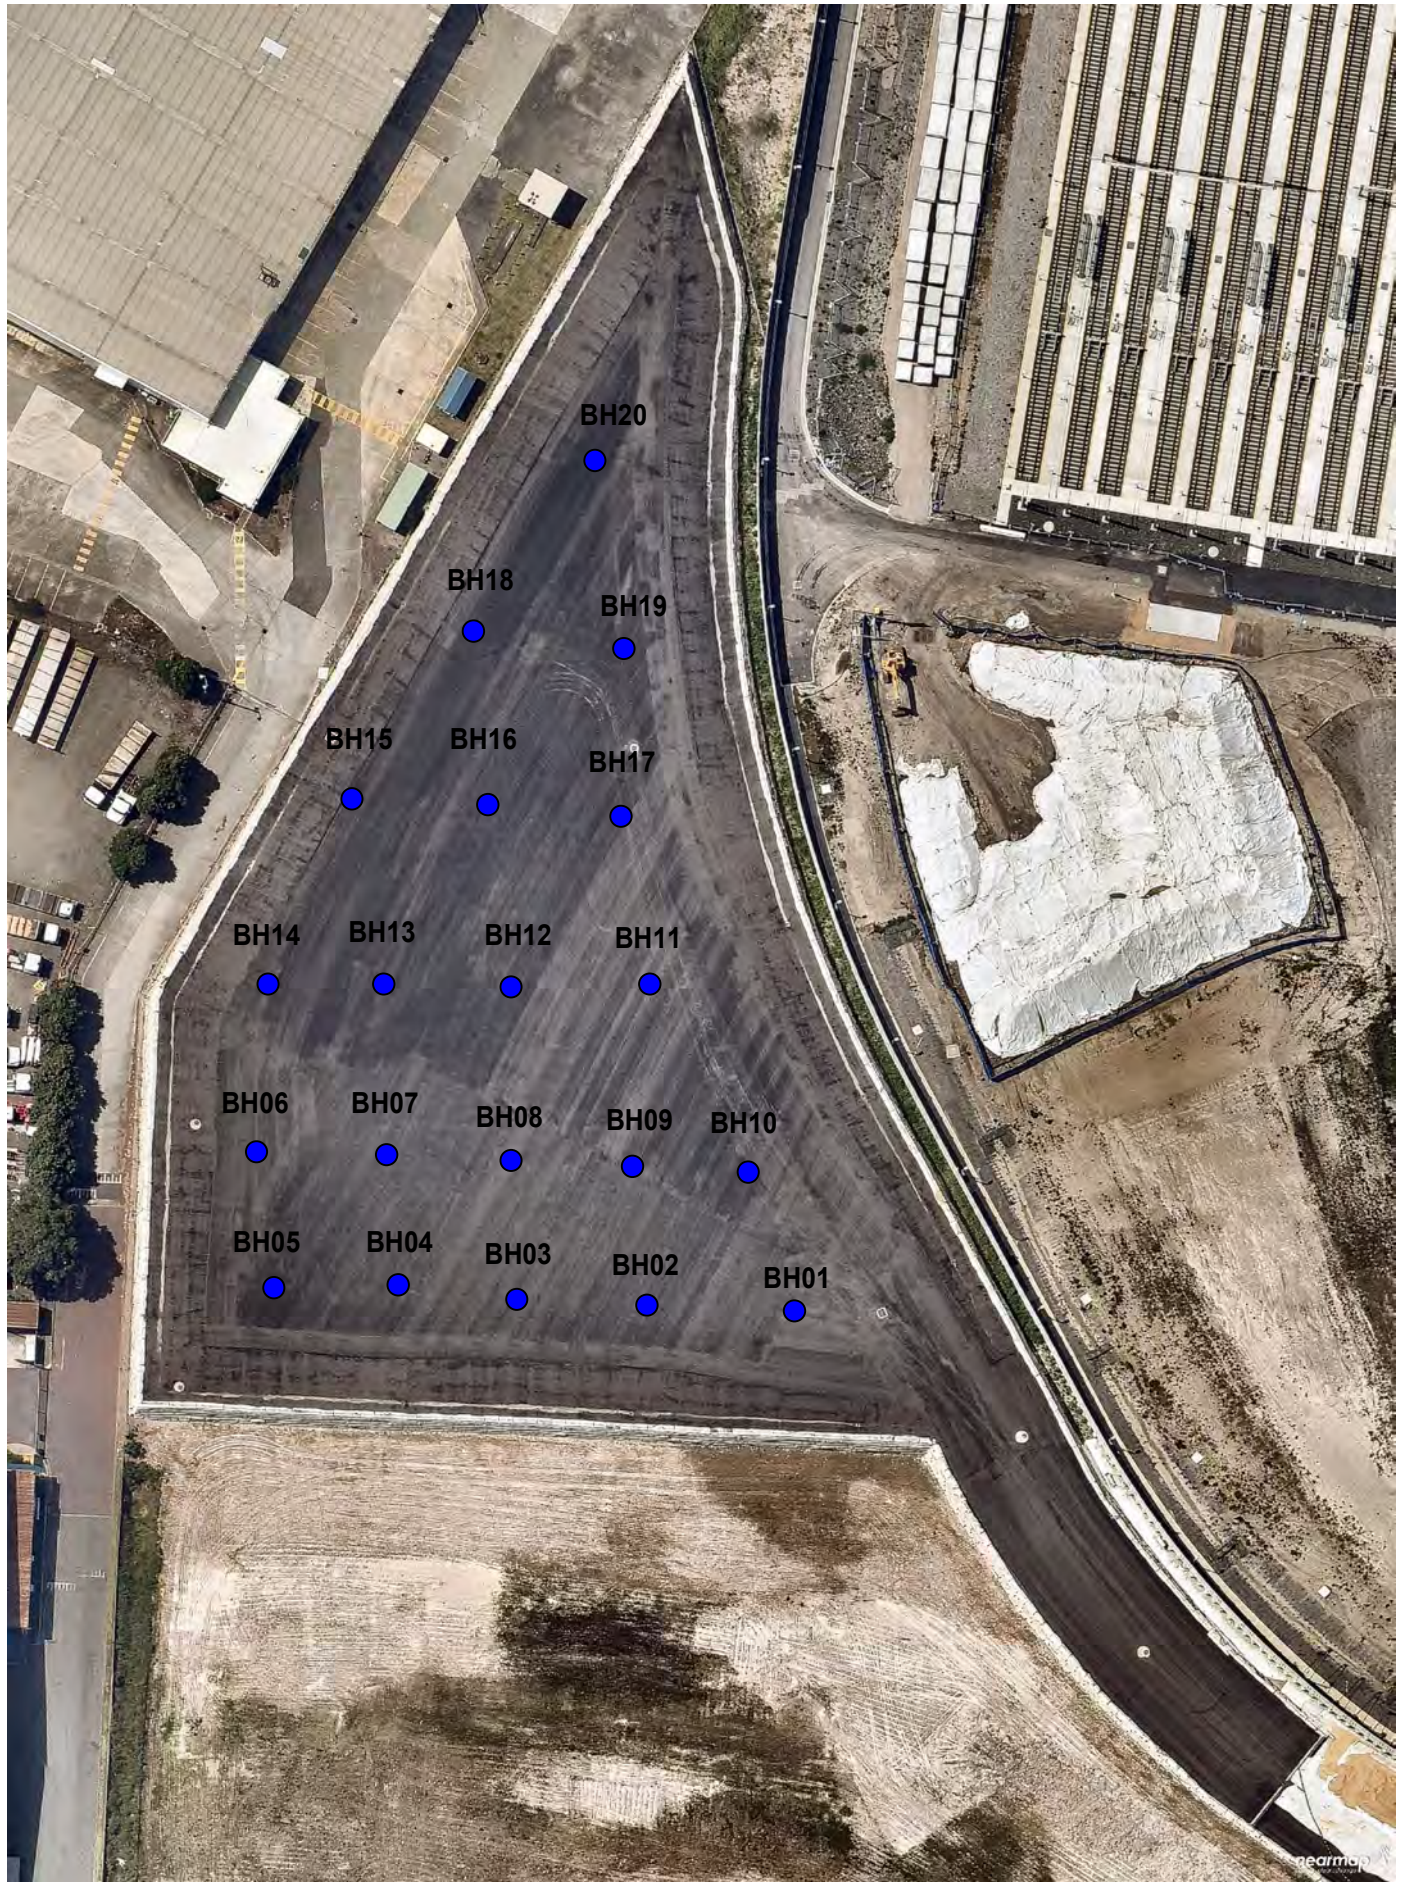
FIGURE 3 – SAMPLING LOCATIONS

- Inspection of the Site;
- Excavation of 25 boreholes;
- Collection of 25 asbestos samples from fill and asbestos fragments (where identified in fill material);
- Collection of 25 primary chemical samples including three QA/QC samples; and,
- Field assessment of aesthetic conditions, including soil type, fill material depth, odours and staining (if any), visible asbestos (if any) and foreign material inclusions.

● Borehole Locations

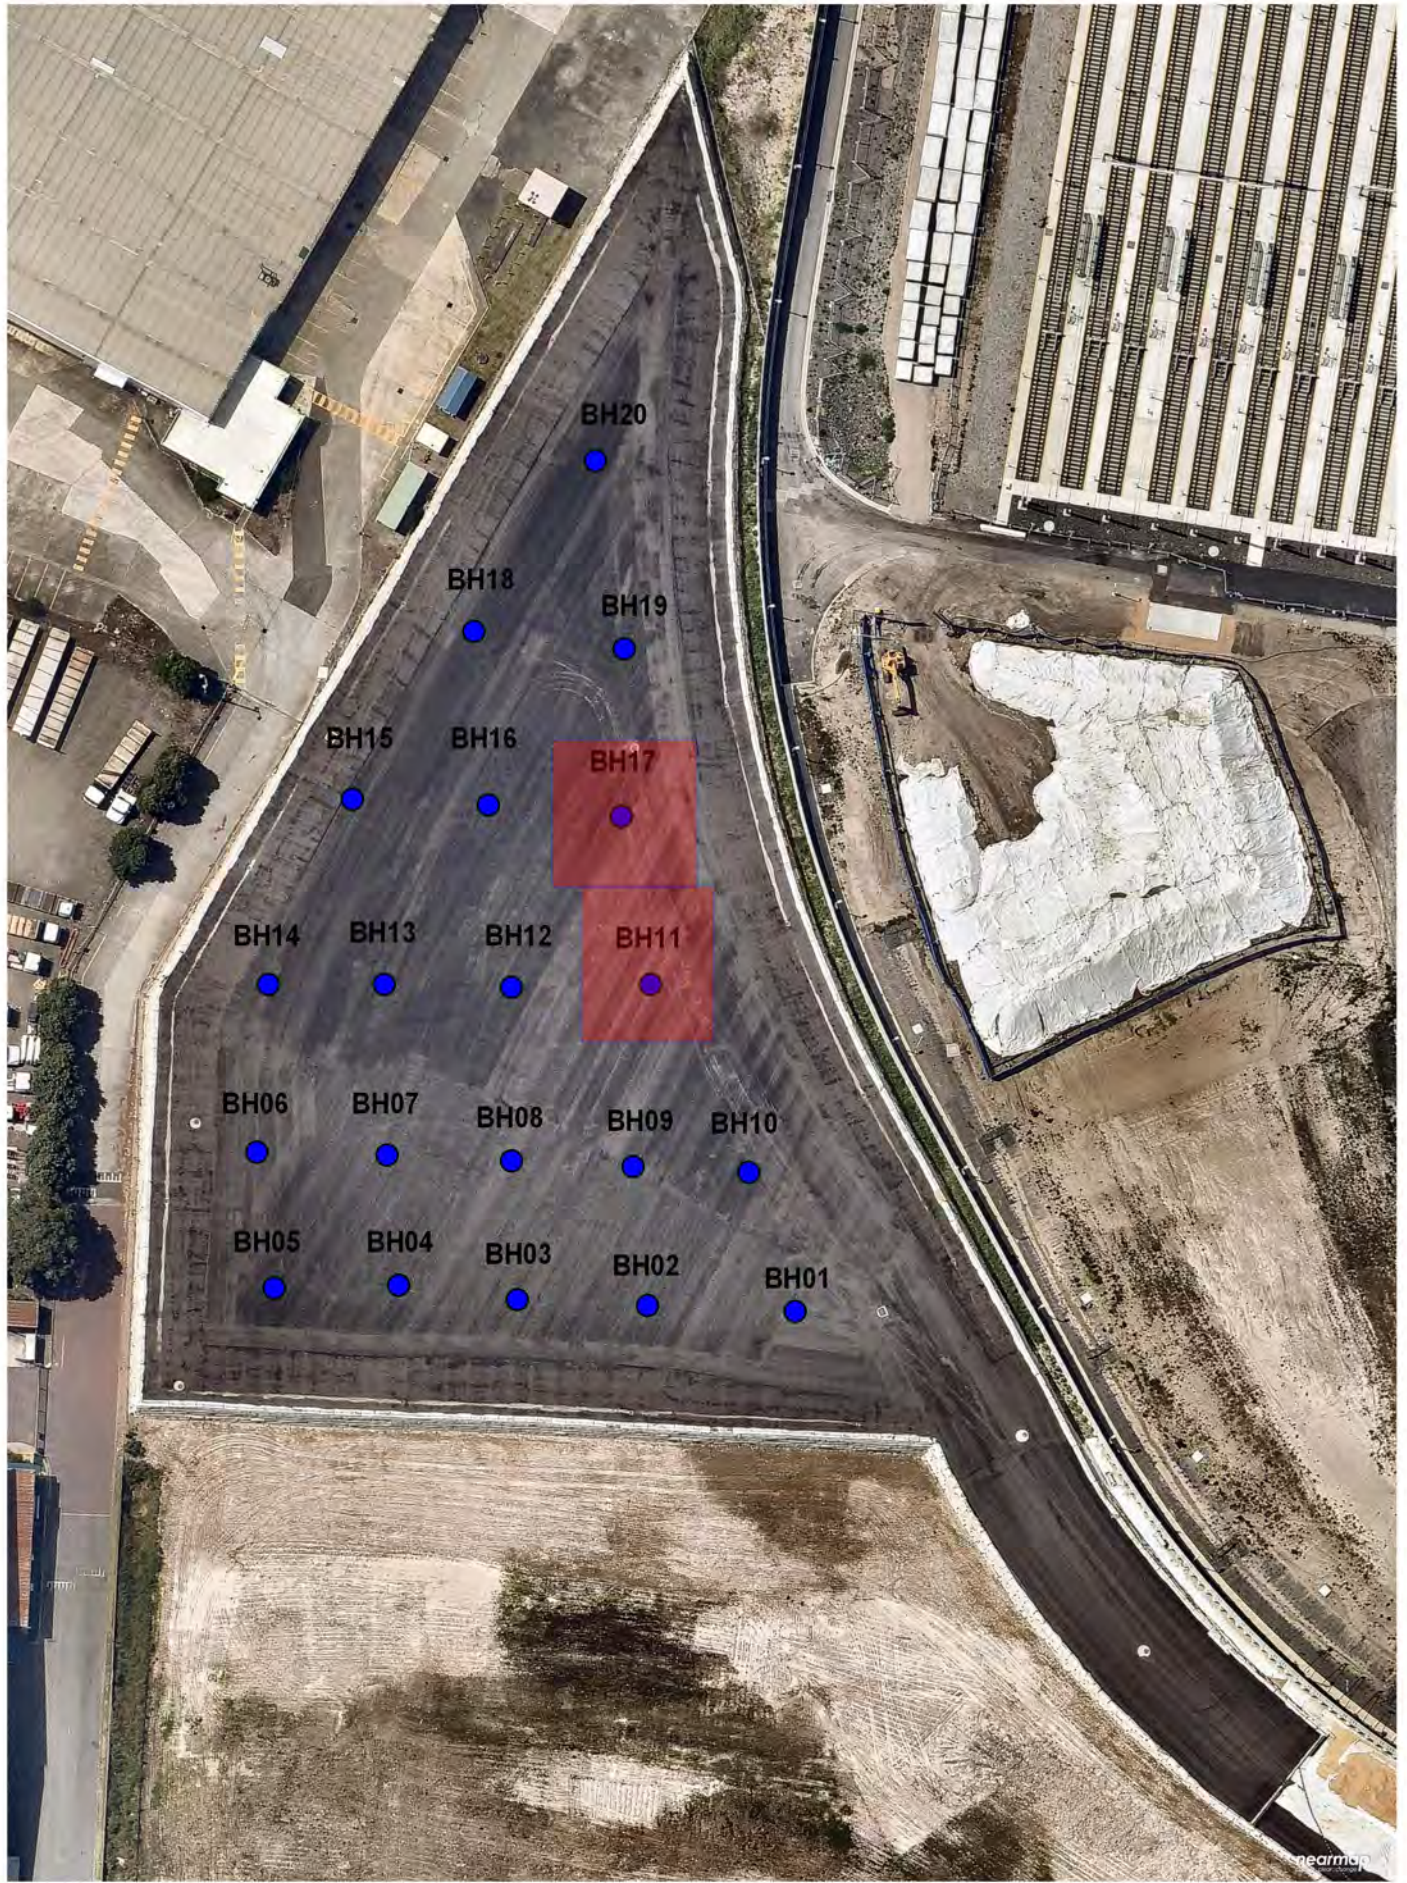
FIGURE 4 – AF/FA HOTSPOTS

AF/FA was noted above the proposed land use criteria of 0.001% in two samples (BH11 and BH17). Samples with AF/FA detections were collected from a depth of approximately 3m. Based on the previous remedial activities at the Site and construction of the containment cell, this would indicate that the AF/FA contaminated stockpiles and hotspots at the Site previously existing at the site, were placed at the base of the containment cell with the additional less contaminated materials placed above to complete the final capacity of the containment cell.

- Borehole Locations
- Identified AF/FA Hotspot
