Heritage Inventory Sheet

Item Name	Goodlet & Smith (brickmaking plant and chimney and Hoffman kiln and chimney)		
Recommended Name	Former Goodlet and Smith Brickworks Site		
Site Image

Item Name	"Pitt Cottage", Late Victorian Cottage		
Recommended Name	'Pitt Cottage'- Late Victorian Cottage		
Site Image

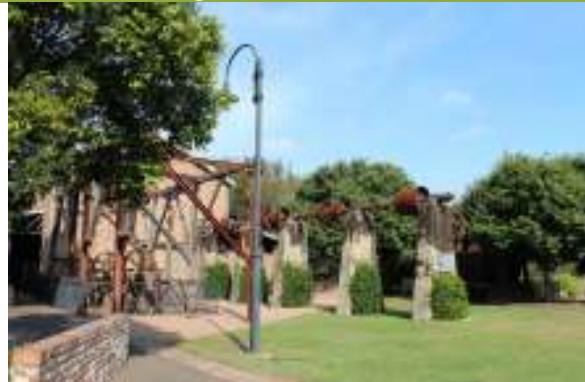
Machinery associated with the Goodlet and Smith Brickwork Site.

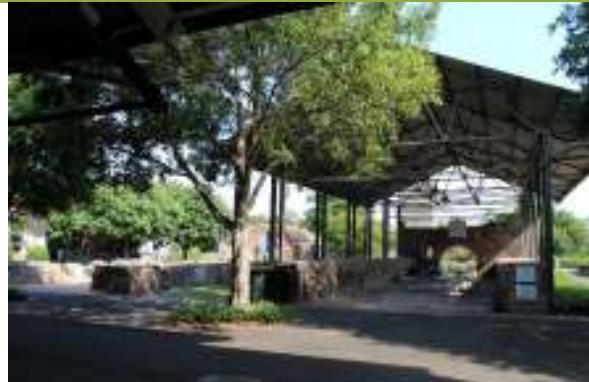
The remnant structures relating to the Goodlet and Smith Brickworks site have been well maintained and have measure in place such as security fences and roof structures to support their conservation. The item is therefore considered to be in a good condition.

Overview of remnants of Goodlet and Smith Brickworks Site.

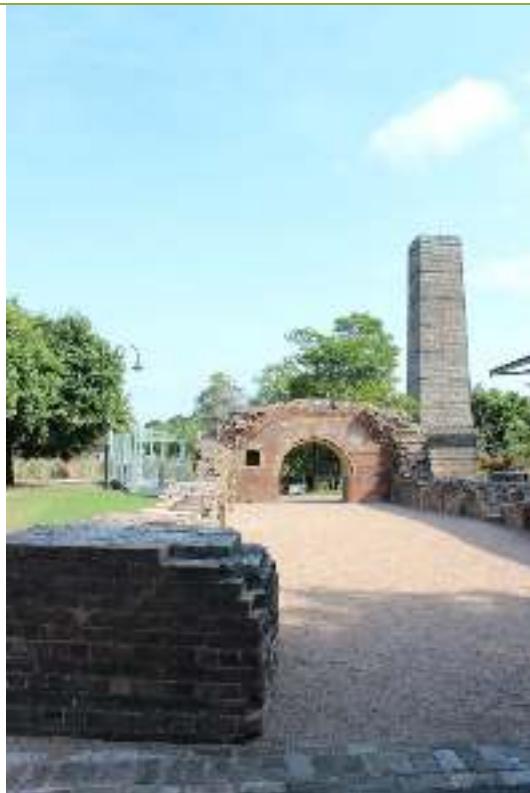
A square-ended brick chimney stack (Stack No 2) is situated to the west of the down draught kilns and is associated with these kilns. It is noted that underground flues would have led to this chimney which was originally 100 feet high.

View to remnant structure and square-ended chimney.

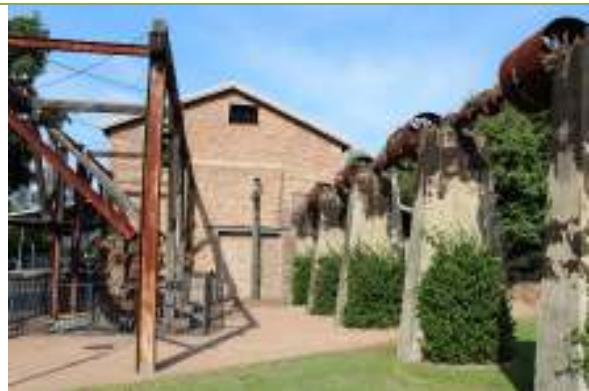
Structures associated with the Goodlet and Smith Brickwork Site.

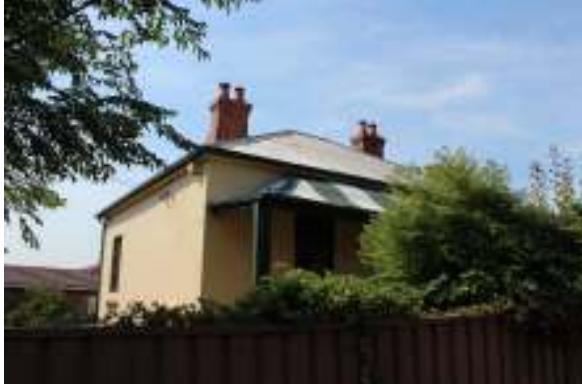
The dwelling is a symmetrical rendered brick Victorian style cottage. It appears as single storey from the street but contains a lower floor which fits in with the slope of the site. The building features a simple hipped roof of corrugated iron and a pair of face brick chimneys with stepped profiled detailing. While the front and side roof planes appear to have been replaced in the recent past, the rear elevation appears to be earlier fabric. The verandah contains a corrugated iron ogee roof that extends along the front façade. The verandah roof is supported on simple timber posts with chamfered corners set on a concrete floor. The symmetry of the front facade is configured with a central door and single timber windows on either side. Each window opening has a segmental arched head and rendered sill. On the front and northern elevations, it is clear that windows have been replaced with aluminium frames and the original window cavity infilled at the bottom to cater for the smaller aluminium frames. The rear of the dwelling has a small skillion lean-to at the south eastern corner of the house.

View to roof elements at Pitt Cottage.

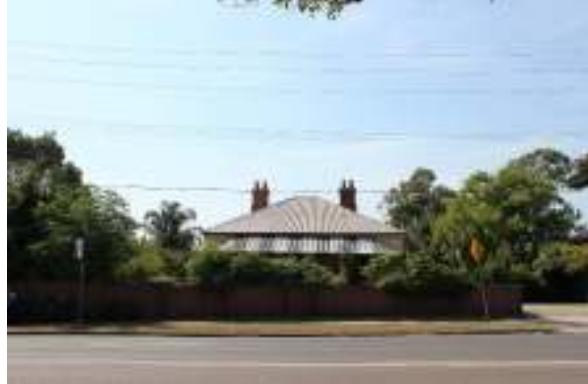
Overall the condition of the item is considered to be good, in particular the timber elements which show no identifiable defects.

Overview of Pitt Cottage.

- Should the opportunity arise, the front fence should be replaced with a timber picket style fence and the landscaping to the front altered to reflect a more sympathetic, European style planting arrangement.
- Should the opportunity arise, aluminium windows should be replaced with timber windows which reflect the original style and design intent of the dwelling. The infilled areas of window openings should be reversed and made good.

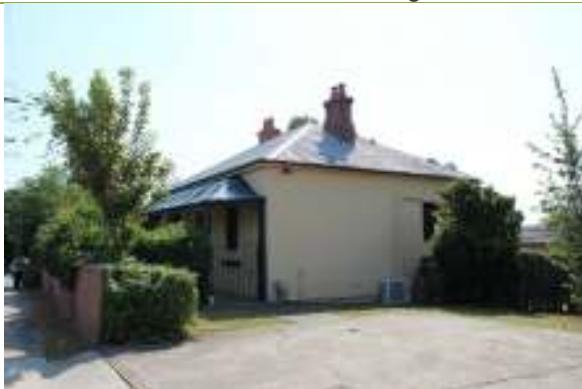
Western and southern elevations of Pitt Cottage.
