Lakewood Estate Riparian Corridor

Plan of Management

February 2023

Environmental Partnership NSW Pty Ltd

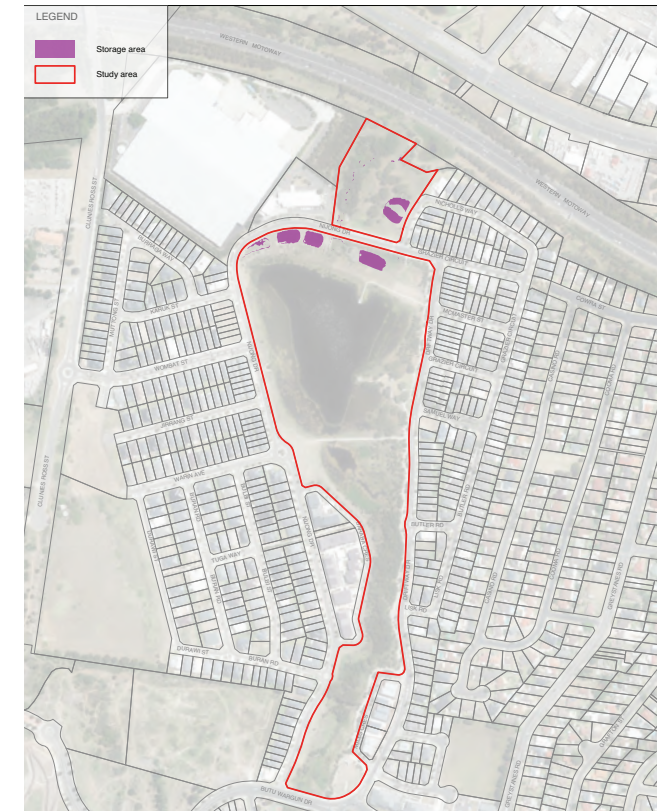
Figure 2.5 Stormwater Mapping
 Source: Cumberland Council

Flow path

High risk flood area

Probable maximum flood extent

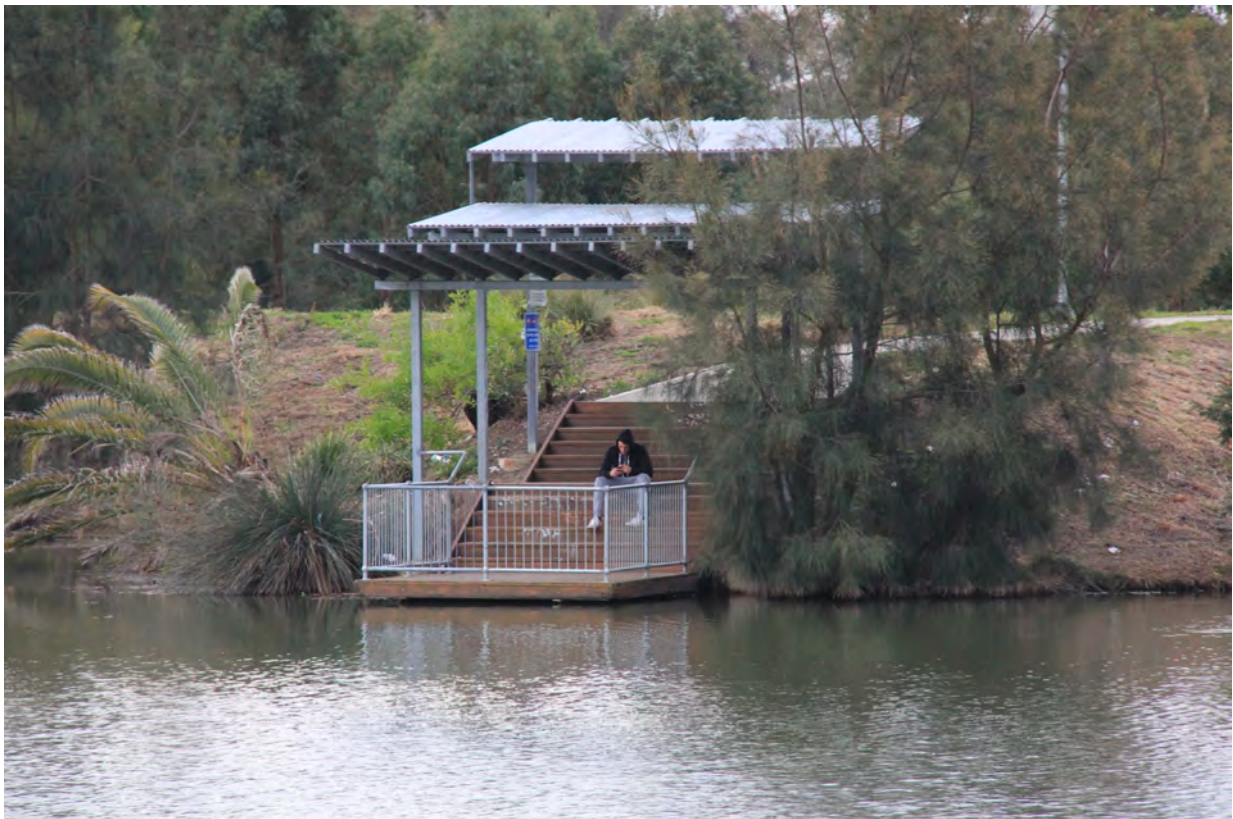
Shelter deck to northern dam wall

The general condition of the structures is fair to good. Some steel and timber surfaces are subject to graffiti, whilst timber decking will require yearly maintenance to assist longevity, and annual monitoring to check condition and fixings.

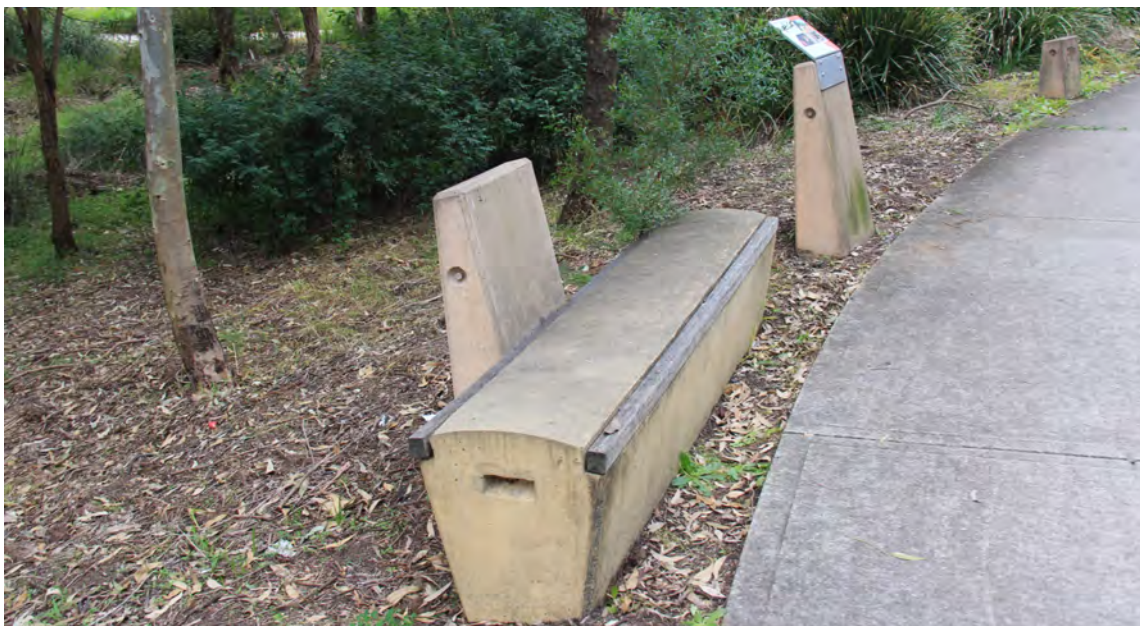
Typical custom seat and signage plinth to corridor as implemented by developer

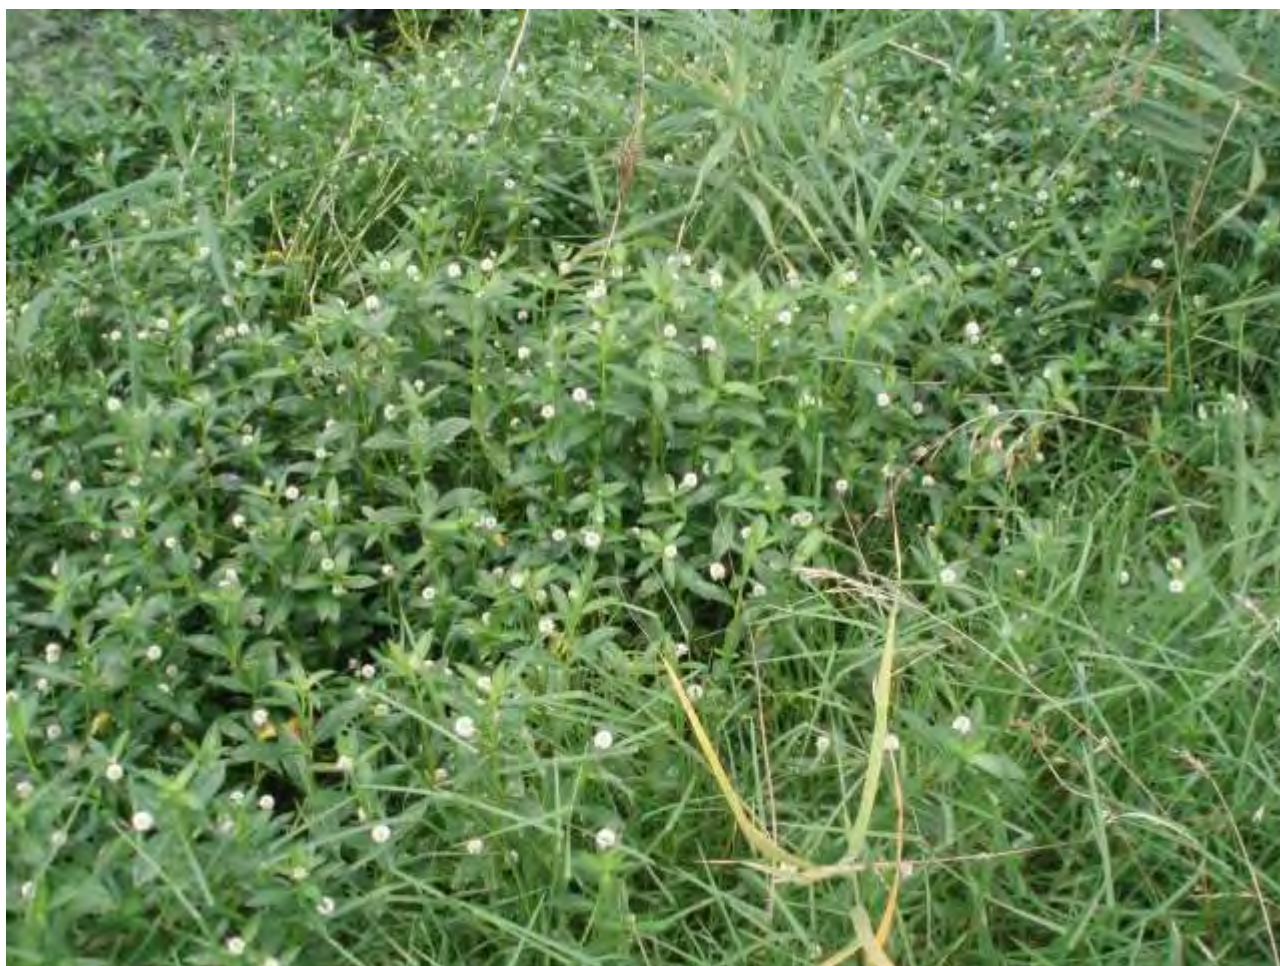
Alligator Weed growing densely in wet-edge habitat and into open water. Source GSDB

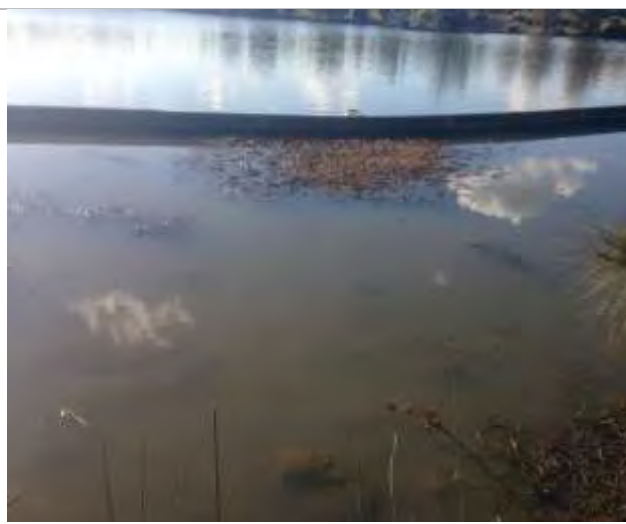
Plate 2: *Juncus acutus* seed in foreground and floating Alligator Weed clump in background

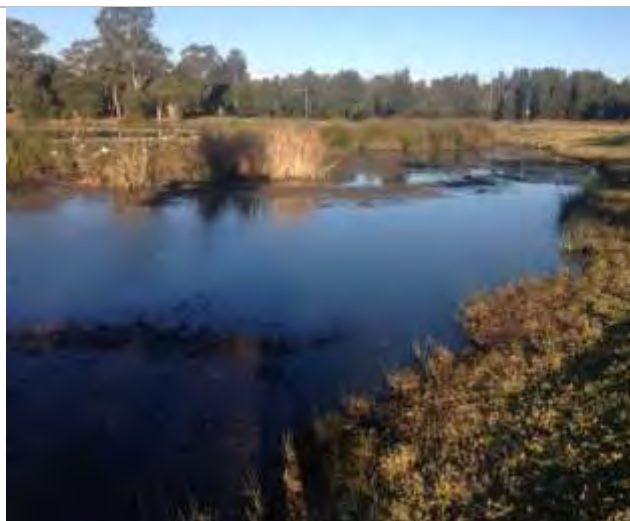
Plate 3: Alligator Weed growing in deeper water and amongst native aquatic vegetation.

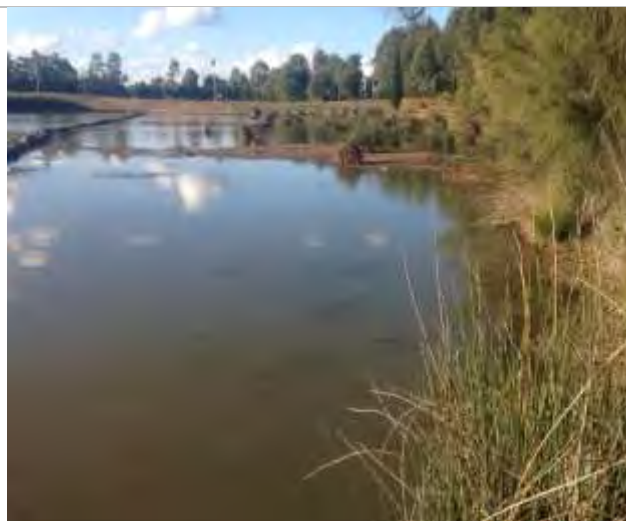
Plate 4: Alligator Weed growing amongst native aquatic vegetation and forming mats and islands within open water sections of wetland system.

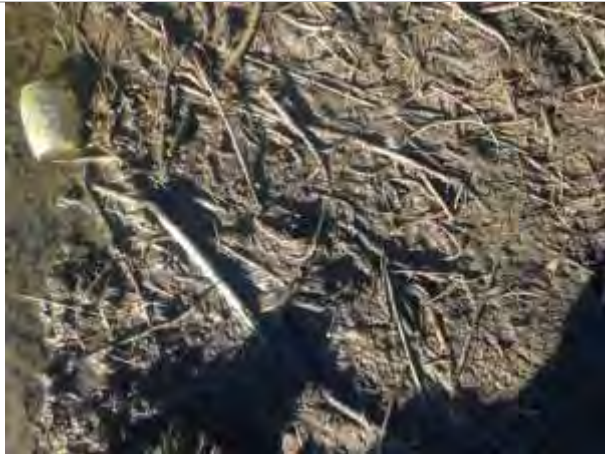
Plate 5: Alligator weed stems and stolons found on exposed muddy substrate.

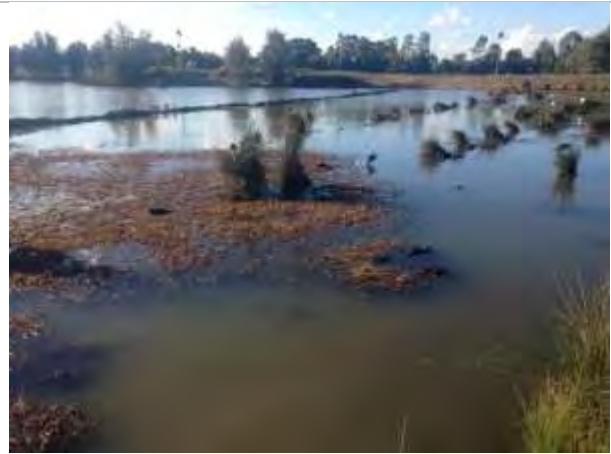
Plate 6: Waterfowl eg Moor Hens and Ibis are foraging on Alligator Weed and aiding its spread across the site and catchment.

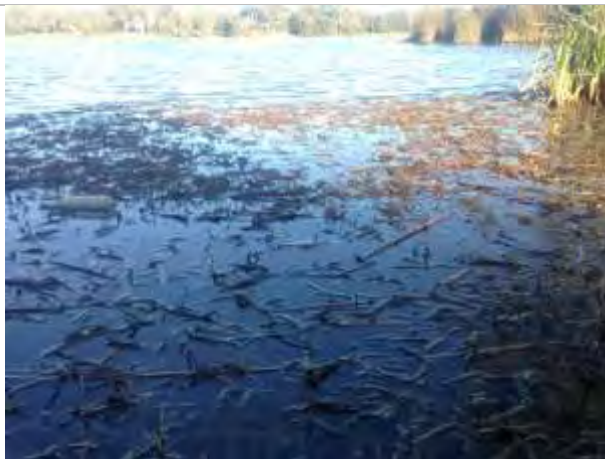
Plate 7: Alligator Weed stems floating in wetland. These will reshoot in warmer weather

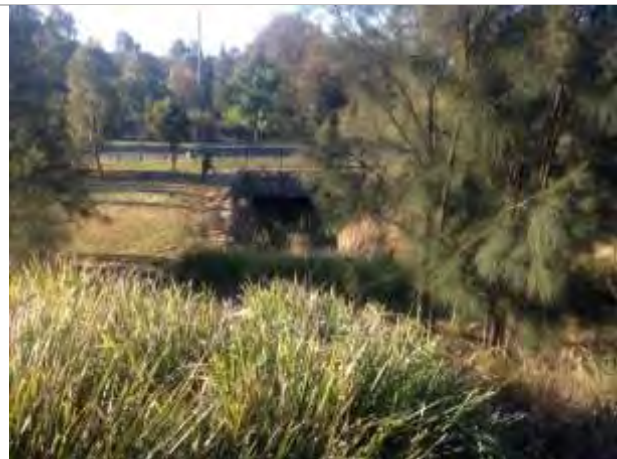
Plate 8: Alligator Weed found in drainage swale that runs along Nijong Drive

Alligator Weed was predominantly in northern pond and in drainage swale that runs along northern section of Nijong Drive as per Figure 5.

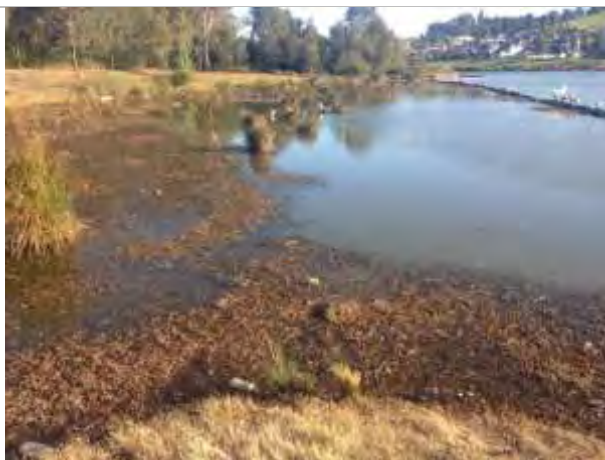
Plate 9: Alligator Weed growing in shallow water and amongst native aquatic vegetation.

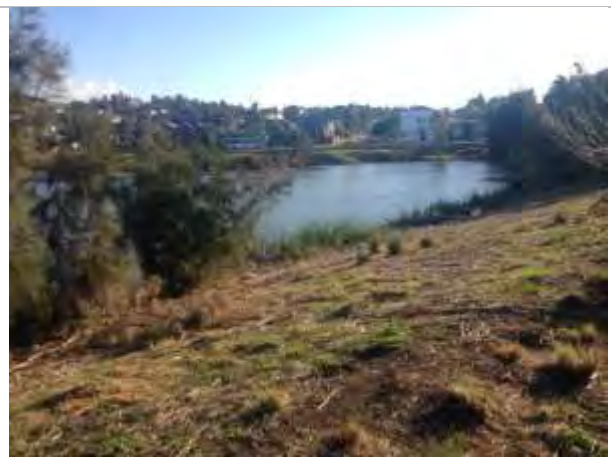
Plate 10: Brushcutting of areas where Alligator Weed is growing in water and on bank is to be avoided
