## Heritage Inventory Sheet

<b>Item Name</b>	Late Victorian Cottage		
<b>Recommended Name</b>	Late Victorian Cottage		
<b>Site Image</b>

<b>Address</b>	121 Hawksview Street, Merrylands NSW 2160		
<b>Lot/Section/DP</b>	22	–	24620
<b>Draft Cumberland LEP ID</b>	I141		
<b>Former LEP ID</b>	I42 (Holroyd LEP)		
<b>Heritage Conservation Area</b>	Not included		
<b>Date Updated</b>	March 2020		
<b>Significance Level</b>	LOCAL		
<b>Site Type</b>	Level 1	Built	
	Level 2	Residential buildings (private)

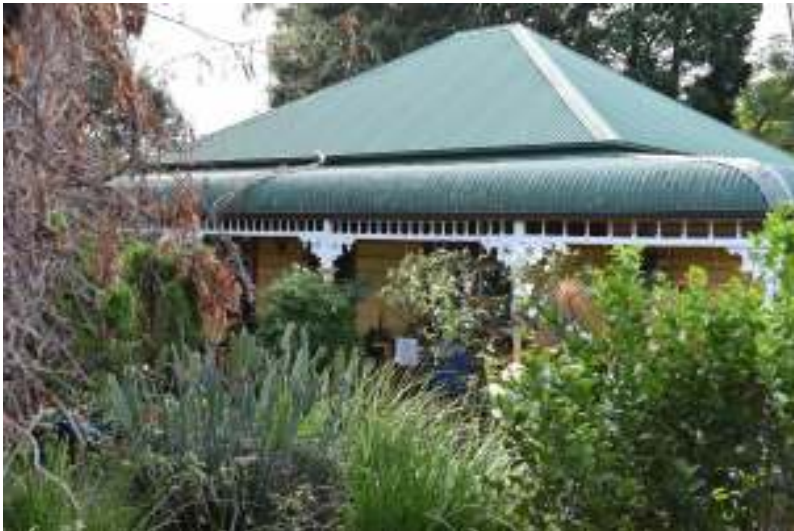
The dwelling is a single-storey weatherboard residence with a hipped roof of Colorbond sheeting. The roof has a single brick chimney on the western side of the house with a single terracotta chimney cowl. A bullnose verandah wraps around the southern and eastern sides, and is supported by decorative timber posts, brackets and frieze. The verandah has a raised timber boarded floor and Colorbond roof. The front facade is symmetrical around a central door, however, the eastern section of the verandah has been infilled with similar weatherboards. The weatherboards to the façade are deeper in width than the boards to the side of the house. The door is timber panelled and has a glazed top light and an aluminium security screen. Adjacent to the door is the electrical panel. On either side of the door is a pair of timber framed double hung windows with decorative timber architraves and sills, as well as fly screens. Windows to the verandah infill are now aluminium sliding, replacing original timber windows. At the rear is a flat roofed addition also clad with weatherboard.

Overall, the condition of the building good. With such a dense vegetation setting, there is biological growth evident on the roof.

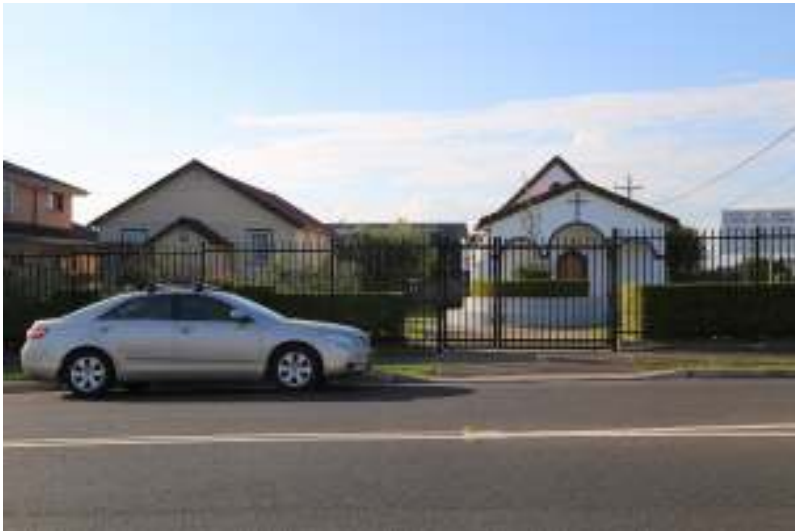
The Church and Hall are both well maintained and appear to be in good condition. There are some minor repairs required to the timber elements of the hall. There is some paint peeling along the bargeboard and architraves.

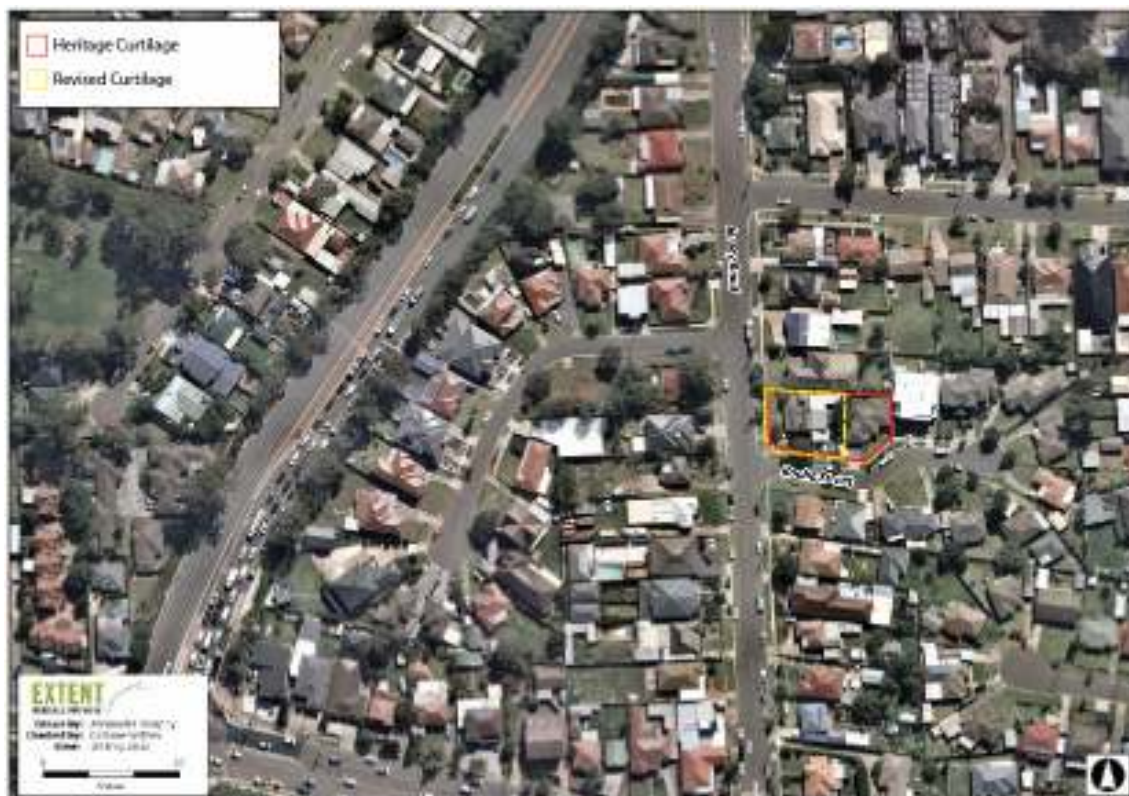
- Due to the subdivision and redevelopment of Lot 2, DP1145417, the revised heritage curtilage shown below should be considered for the Cumberland LEP.

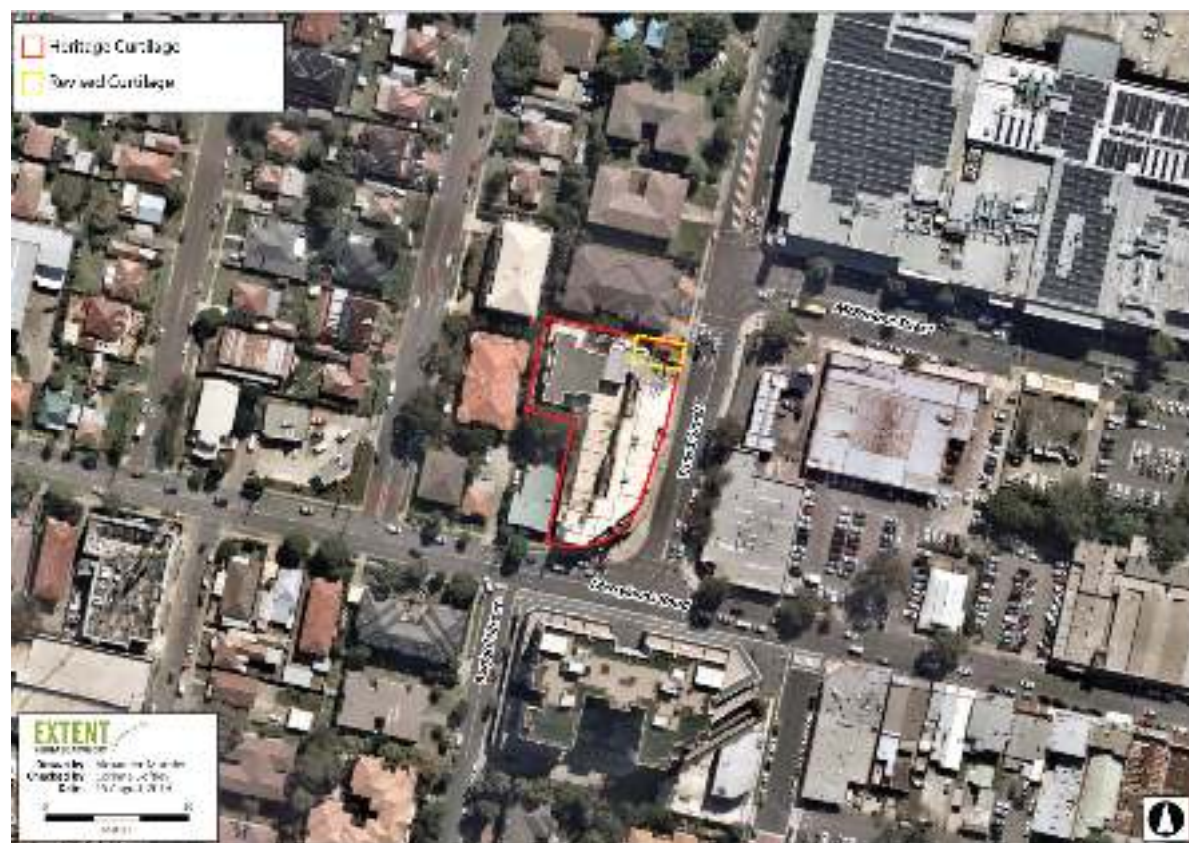
- Explore opportunities for adaptive reuse so that its presence within the community and its condition is maintained.
- The land surrounding the electricity substation has been redeveloped for the inclusion of a medium density residential apartment block. The heritage curtilage should be revised as shown in the figure below for the Cumberland LEP. Should the revised curtilage be adopted, this listing sheet does not reflect the current Lot/DP which will need to be altered.

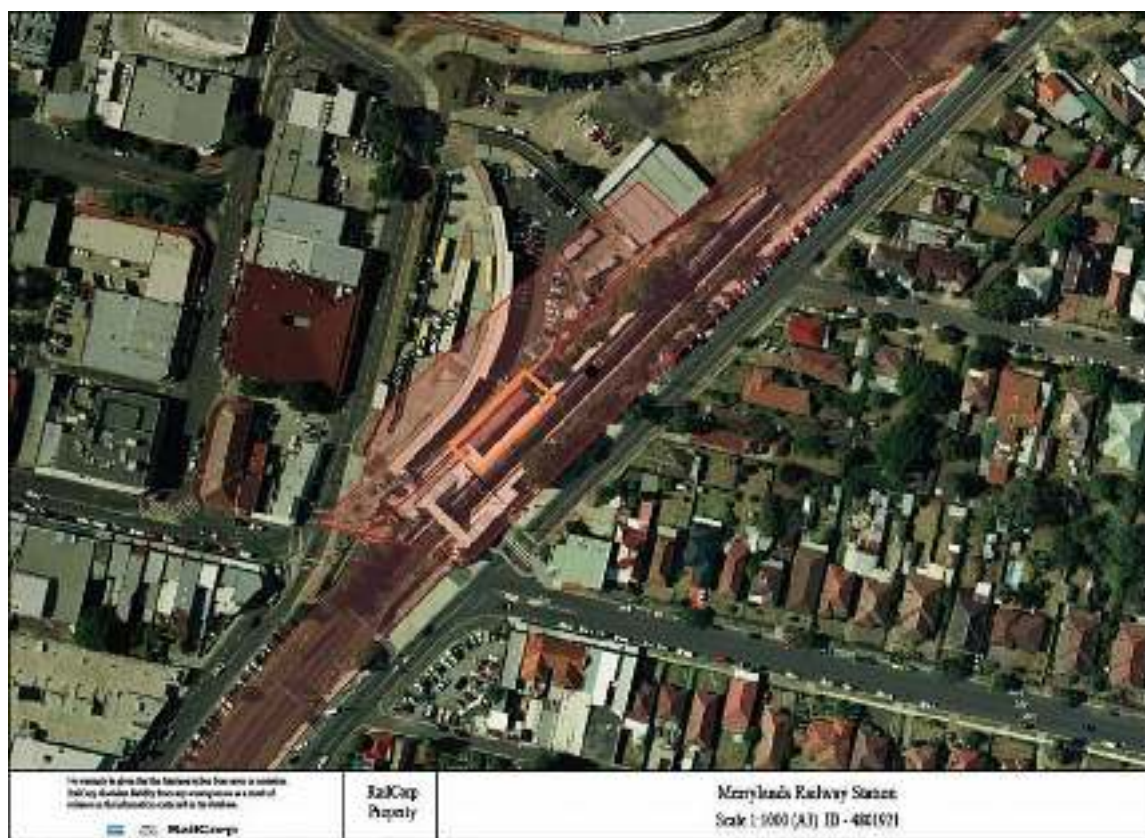
- The heritage curtilage for the Cumberland LEP should be revised to match the RailCorp Section 170 Heritage and Conservation Register curtilage for the station; item #4801921. Refer to the plan below, showing the orange curtilage. Should the revised curtilage be adopted, this listing sheet does not reflect the current Lot/DP which will need to be altered.

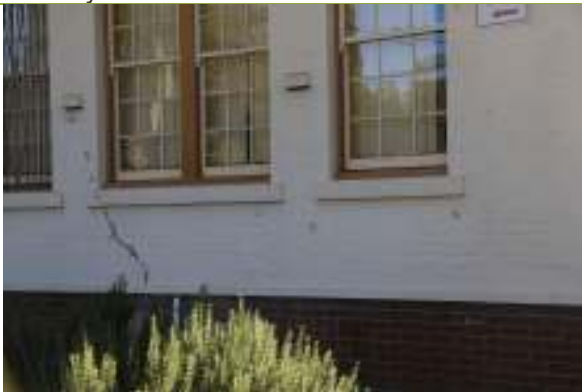
Detail of cracking to brickwork along front façade of main building.

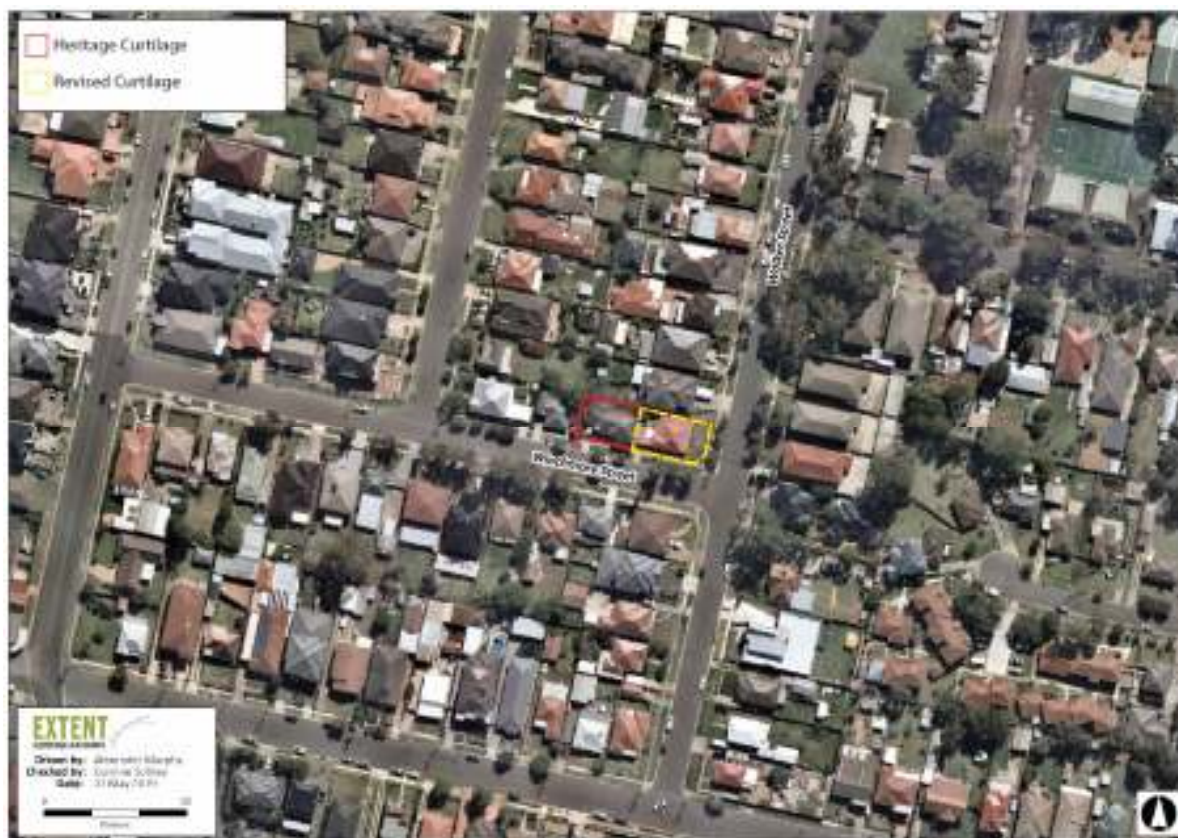
- As the western portion of the current site now includes a modern dwelling of no heritage value, the heritage curtilage shown below should be considered as a revised curtilage for the new Cumberland LEP. Should the revised curtilage be adopted, this listing sheet does not reflect the current Lot/DP which will need to be altered.

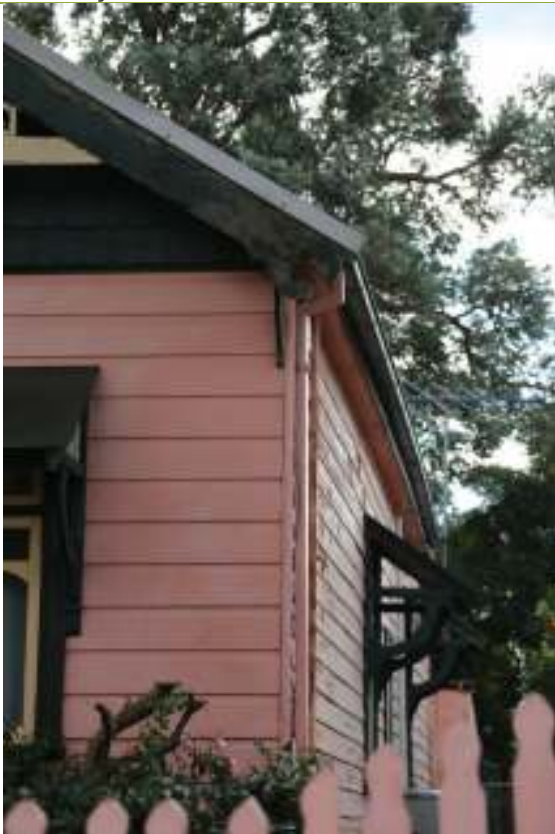
Detail of deteriorated timber to barge board.
