Heritage Inventory Sheet

Item Name	Memorial Reserve, Historic Memorial and Cannon		
Recommended Name	Merrylands Remembrance Park		
Site Image

Item Name	Former Council Chambers c.1914		
Recommended Name	Former Council Chambers		
Site Image

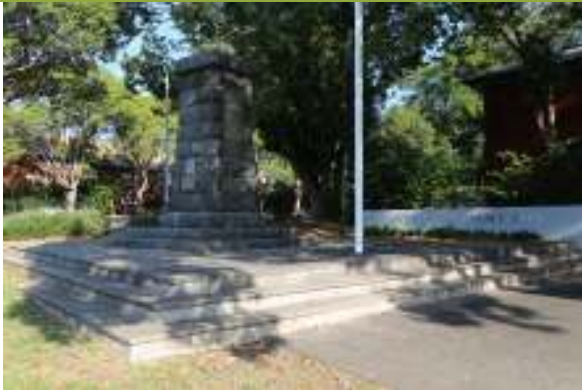
The monument is a solid blue stone obelisk with polished panels with gold lettering commemorating the loss of local men in World War One. The obelisk is situated atop a concrete and tile platform that is built into the landscape and steps down to a tiled path throughout the park that leads to the cannon.

Obelisk.

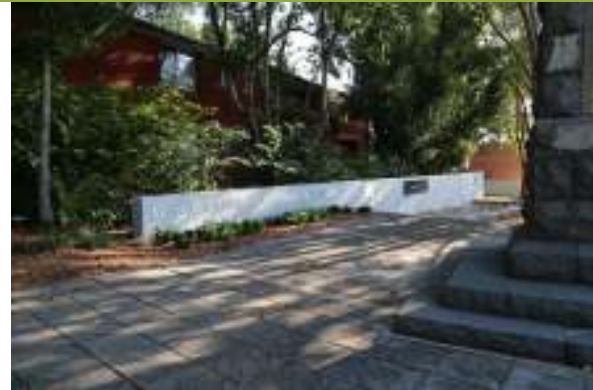
The retaining wall reads 'Merrylands Remembrance Park' and has two plaques affixed.

Rendered brick retaining wall with park name.

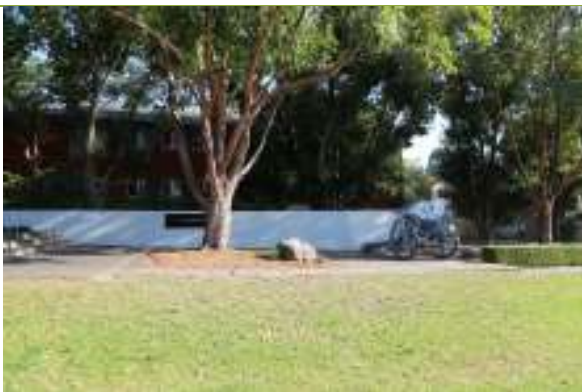
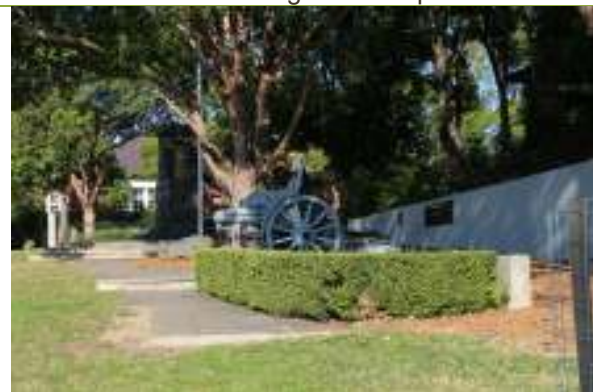
The Merrylands Remembrance Park presents as a well-cared for landscaped area. The built elements within this landscape are in a good condition. There is some evidence of pit corrosion occurring in the joints of the cannon.

View of cannon within landscape setting.

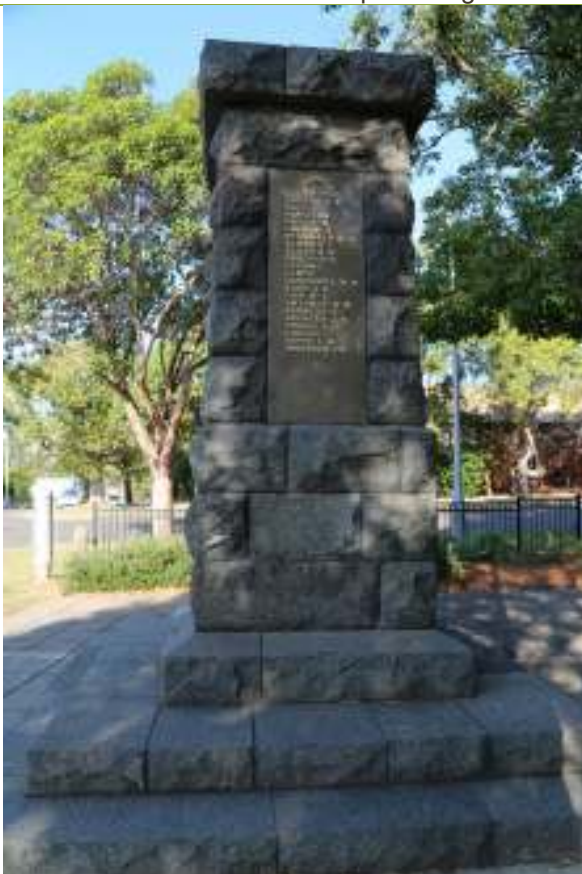
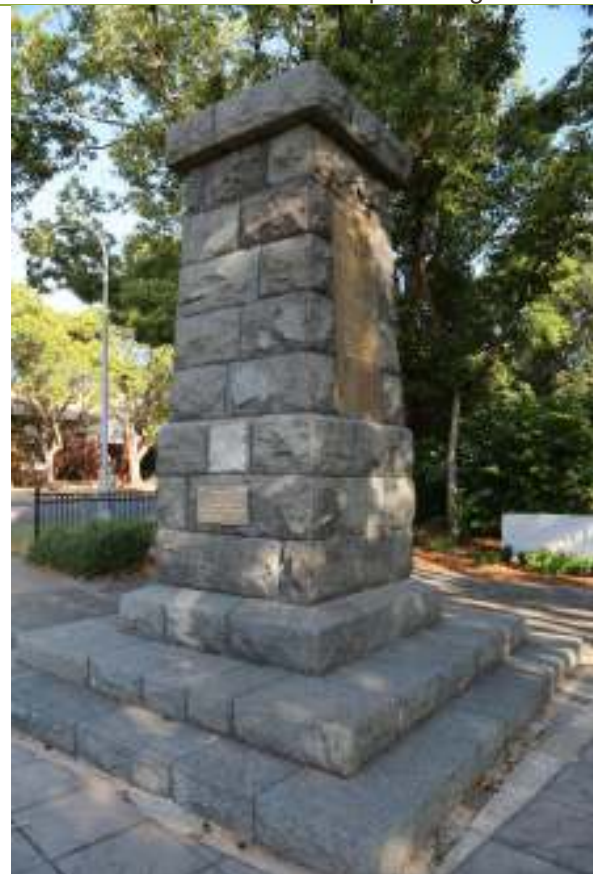
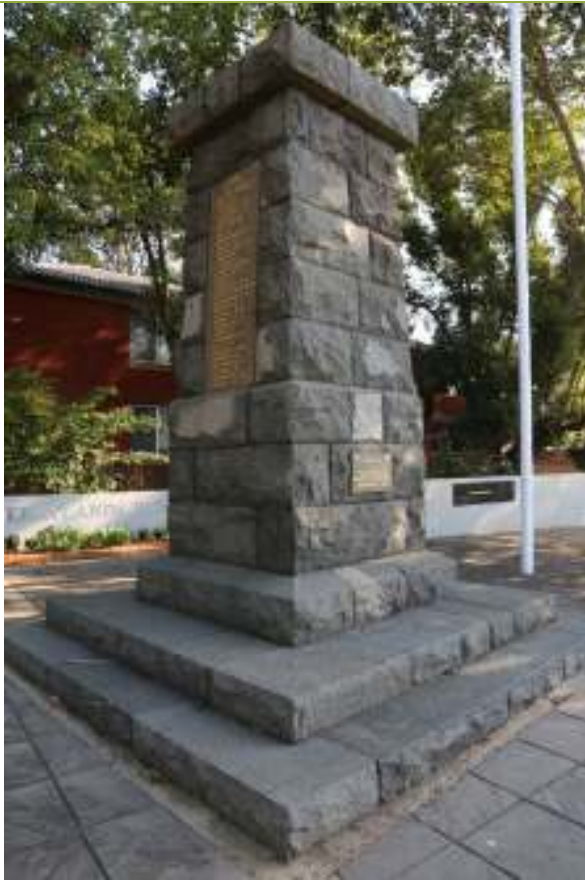
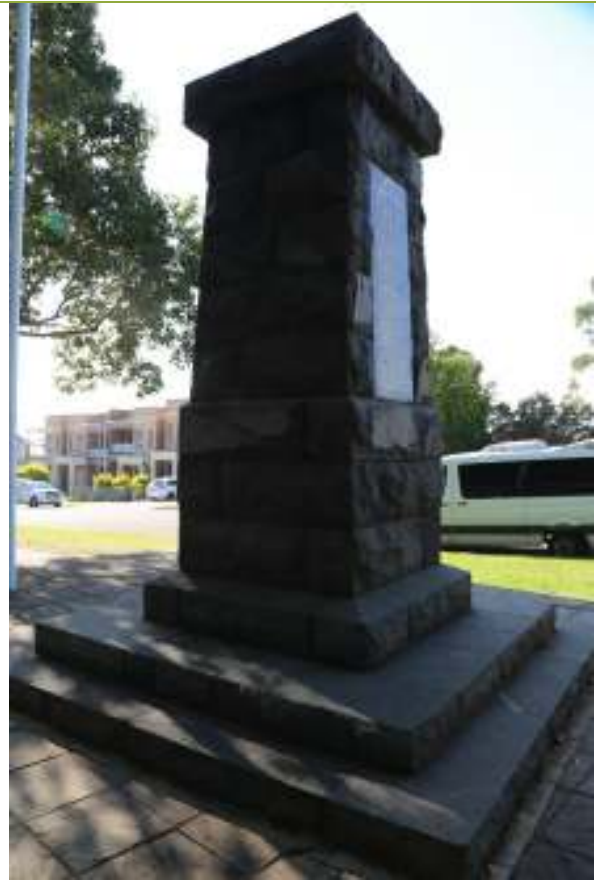
Detail of obelisk.

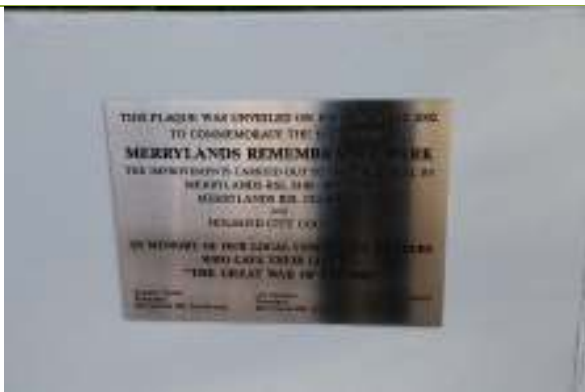
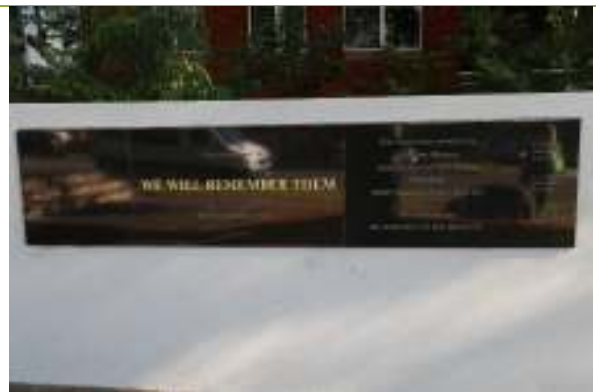
Detail of plaques on the retaining wall.

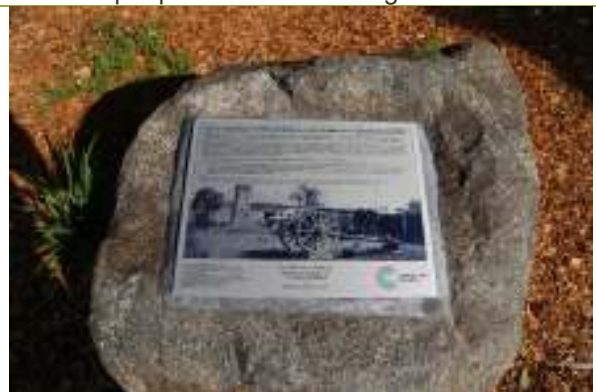
The cannon is a German 'Trophy Gun', 105mm 4.1 Light Field Howitzer, model number 98/09. The serial number is 2701. The cannon features a protective coating to suppress the corrosion and is set into the paved ground. A rock with an anodised aluminium plaque affixed interprets the cannon.

Cannon plaque.

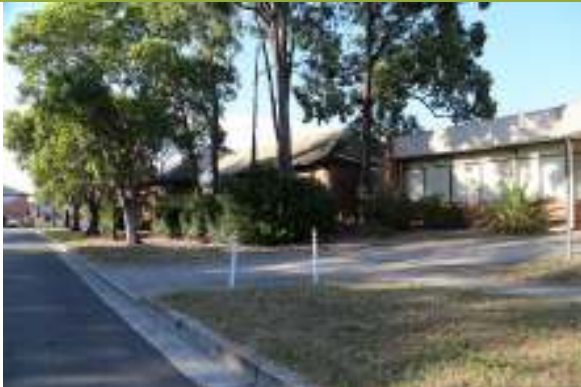
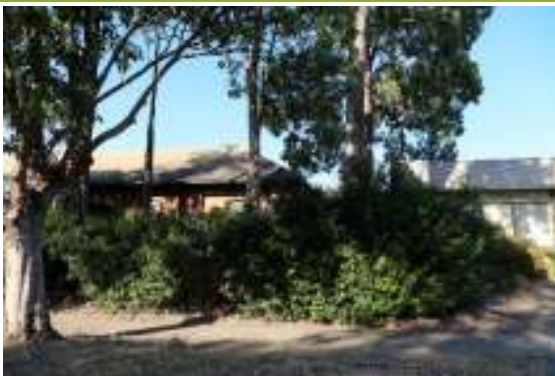
To the west of the former Council Chambers is an attached modern building that is occupied by Dunrossil Disability Services. The addition is a single storey brick building that features large metal framed windows with a horizontal cladded fascia and a brick square parapet at the east and west elevation of the building. The roofscape is predominately flat with a gabled roof at the eastern end.

View from Arthur Street to Former Council Chambers showing 1970s extension.

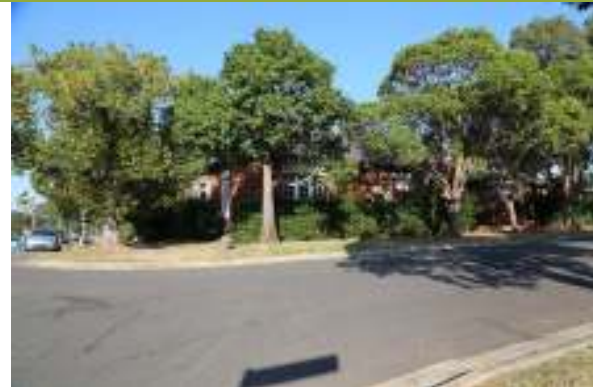
The item features a heavily overgrown formal garden space along Arthur and Arcadia Streets with several established trees and hedges that are unmaintained. The site is bounded by a wire mesh fence with barbed wire along the southern and eastern boundary. There is also a steel palisade gate on the eastern boundary.

Overview of Former Council Chambers from Arthur Street showing surrounding landscape elements.

- Regular building maintenance works should be undertaken to reduce the impact of the overgrown vegetation and debris impacting the building.
- Investigation into the conservation of the brickwork and timber elements should be undertaken prior to the redevelopment of the site.
- It is noted that there is a current DA to redevelop the site. Should this not eventuate, opportunities for re-use should be sought to re-occupy the building. Any adaptation for reuse should be developed with the involvement of a heritage specialist.

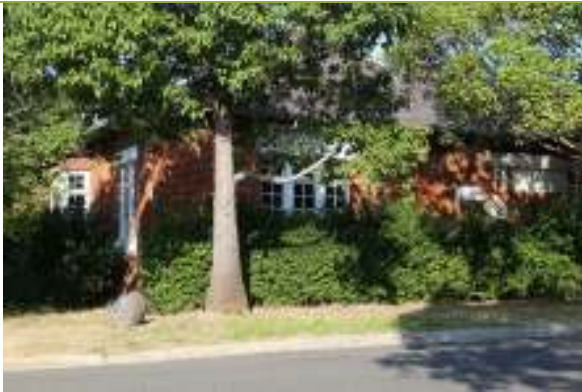
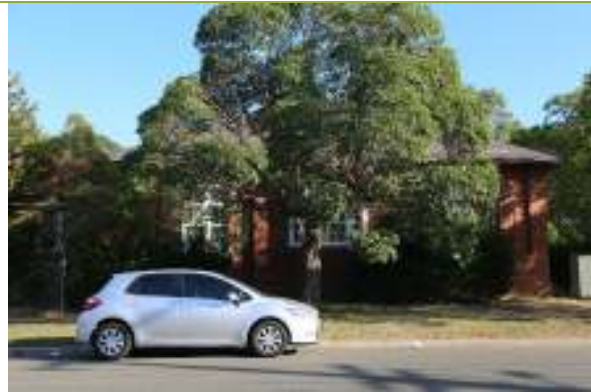
The former Council Chambers built in 1914 is a single storey brick building sited on the corner of Arcadia and Arthur Streets, Merrylands West. The building features a hipped roof of mixed cladding material. The main building features a slate roof with terracotta ridge capping and finials, while the rear wing of the building is clad in corrugated steel and appears to be later addition, possibly c.1920. The roof features replaced guttering, exposed rafters and timber soffits with modern lighting affixed to the eave. The entry to the building is marked by a small brick porch with a rendered gable end accessed off Arthur Street. The rendered gable end consists of a simple rendered pediment with a moulded stringcourse below. The windows are generally multipaned timber framed double hung sash windows with fanlights. The window openings feature a mix of segmented brick arches and rendered lintels and sills. The east elevation fronting Arcadia Street features a timber framed bay window with a multipaned double hung sash window. The bay window features timber shingle cladding above the window.

At present, the former Council Chambers are unoccupied and in a state of disrepair exacerbated by the building's disuse. Overall, its condition is fair with some elements in a poorer condition. Elements degrading, such as brick, timberwork and render, appear to be as a result of poor water management and salt attack. It is imperative that the landscaping is maintained to reduce the impacts of rising and falling damp resultant from the build-up of vegetation around the building. This is evident in the gutters which are overflowing with debris. The gutters are forcing water to fall down the facades which has larger conservation implications for the timberwork, render and bricks.

View to Former Council Chambers from Arcadia Street.

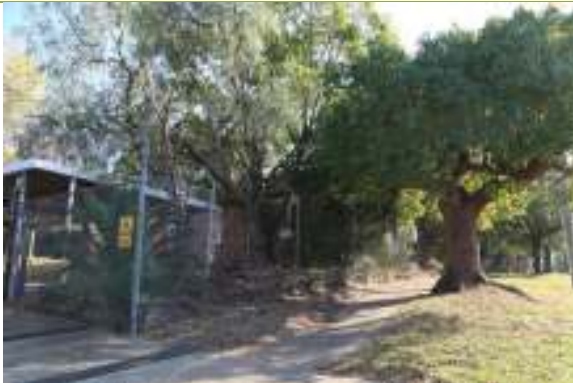
View to fencing around southern and eastern elevations of building.

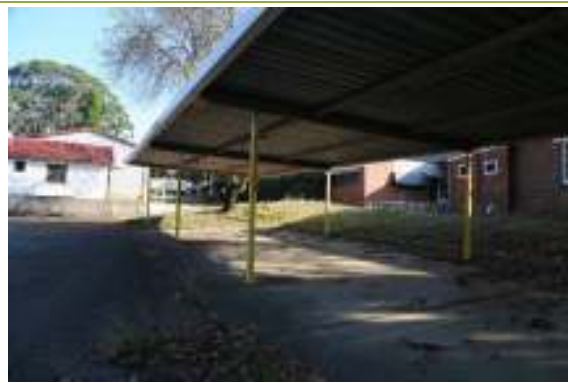
View to grounds within the Former Council Chambers.

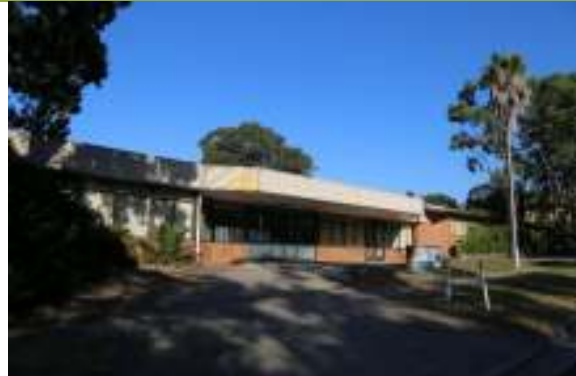
Dunrossil extension viewed from Arthur Street.

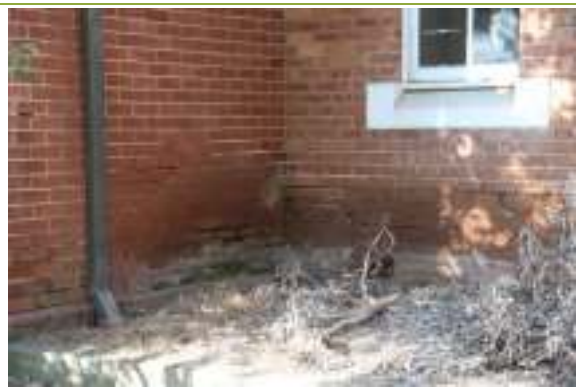
- The guttering requires repair work along all elevations. Not only blocked with debris, the guttering is detached from sections of the roof and is in a poor condition.
- The timber shingles, fascia and soffits show signs of timber rot and are in a fair to poor condition. The timber windows appear to be in sound condition.
- The brickwork along the lower courses show signs of severe salt attack as a result of water ingress. This is particularly evident along the north elevation, next to the entry porch, where the bricks are significantly weathered, missing mortar and damp with some biological growth on brickwork.
- The cracking in the render and brickwork is a result of settlement movement.

Detail of brickwork with severe salt attack on elevation to Arthur Street.

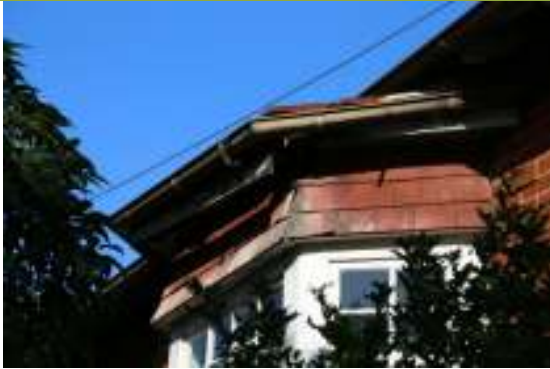
Detail of timber rot to shingles on bay window to Arcadia Street.

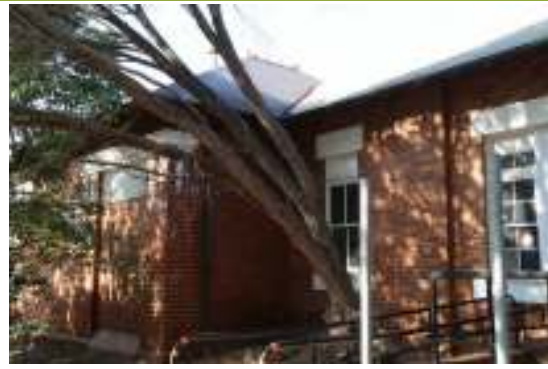
View of northern elevation of Former Council Chambers.

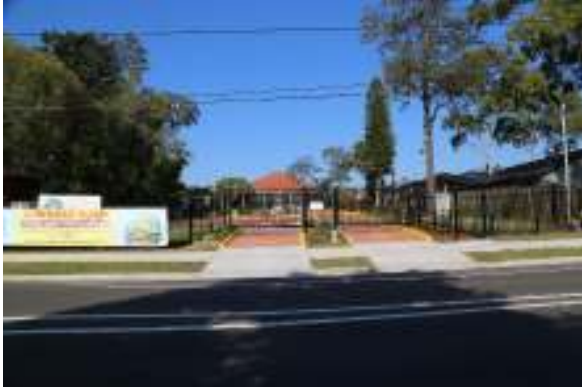
The site contains a large brick Late Victorian cottage. The item has facebrick walls and a hipped roof clad with terracotta tiles. The roof extends over to a broken back verandah roof. A tall brick chimney with a curved brick cowl is located on the southern ridge of the roof. The verandah extends along north, east and west elevations, and is supported on replaced timber posts. The verandah is addressed by five steps clad with tiles. The land immediately fronting the verandah has been landscaped to include garden beds with simple timber panel retaining walls. The windows are generally timber framed multi-paned casement, and do not appear to be original. A central entry door has glazed panels and side lights.

View of dwelling from Paton Street.

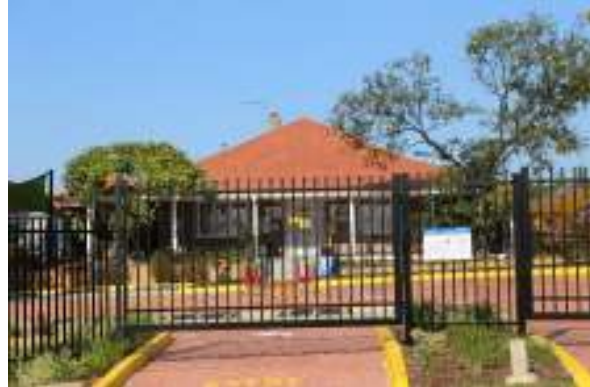
View of front façade behind the entry driveway and gate.

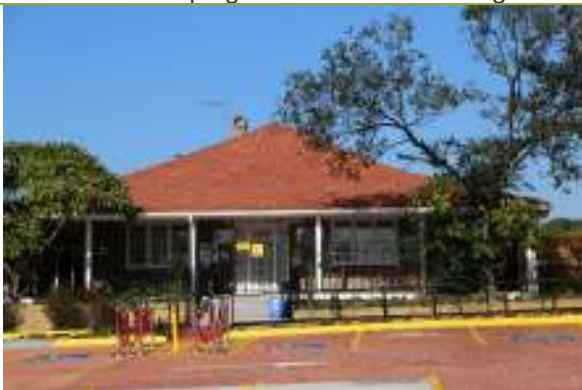
Front façade.
