Heritage Inventory Sheet

Item Name	Colquhoun Park, including palm trees and monument		
Recommended Name	Colquhoun Park, including palm trees and monument		
Site Image

Item Name	Houses built for Housing Commission		
Recommended Name	Blaxcell Street Houses Built for Housing Commission		
Site Image

Item Name	Electrical Substation		
Recommended Name	Electricity Substation		
Site Image

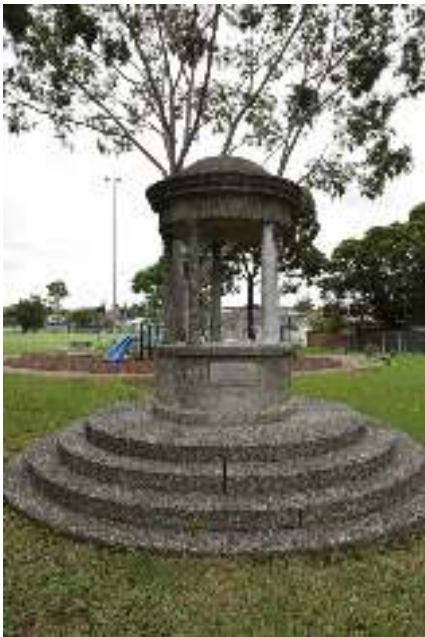
The park itself is a large open area reserved for public recreation. The park offers significant landscaping elements such as an avenue of landscaped exotic trees including tall palms, silky oak, one fig and recent complementary replacement planting of two jacarandas, which all appear to be complementary to the memorial in the front of the park. The park also features asphalted netball courts, concreted footpaths, a children's playground, cricket nets, and an amenities building.

Both the memorial and park appear to be in good condition, the memorial has recently had a new aluminium dedication plaque affixed.

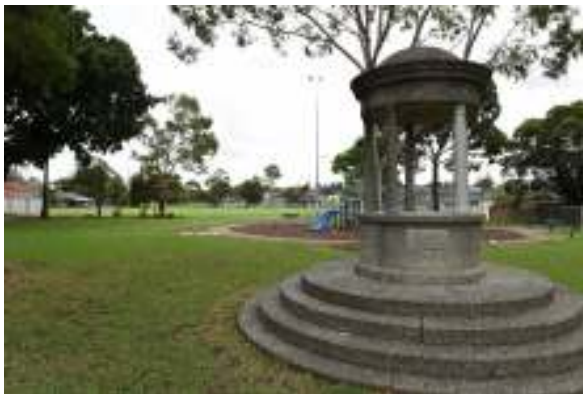
View northwest from Blaxcell Street to monument in Colquhoun park.

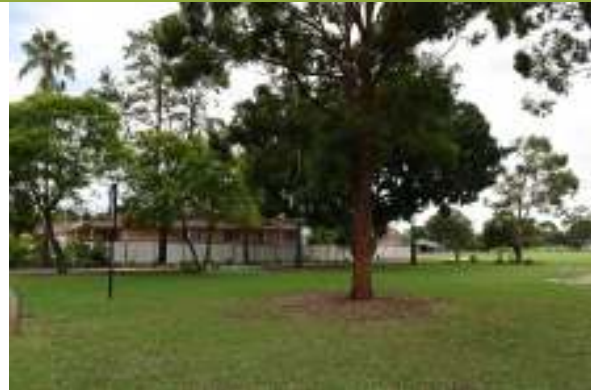
View west from Blaxcell Street to Colquhoun park.

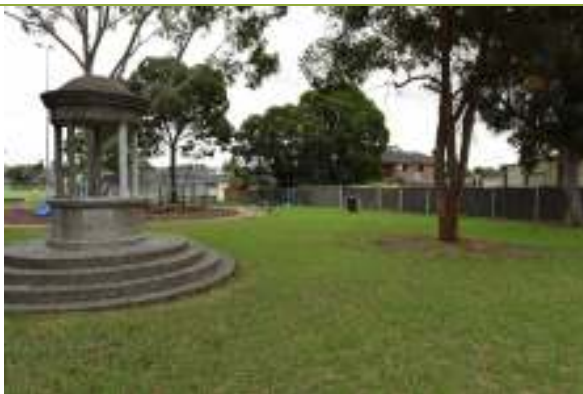
- A new replacement aluminium dedication plaque has been installed on the memorial.
- Elements such as playground equipment and amenities are modernised.
- Some plantings have been replaced; others potentially removed.

View northeast from Blaxcell Street to monument in Colquhoun park.

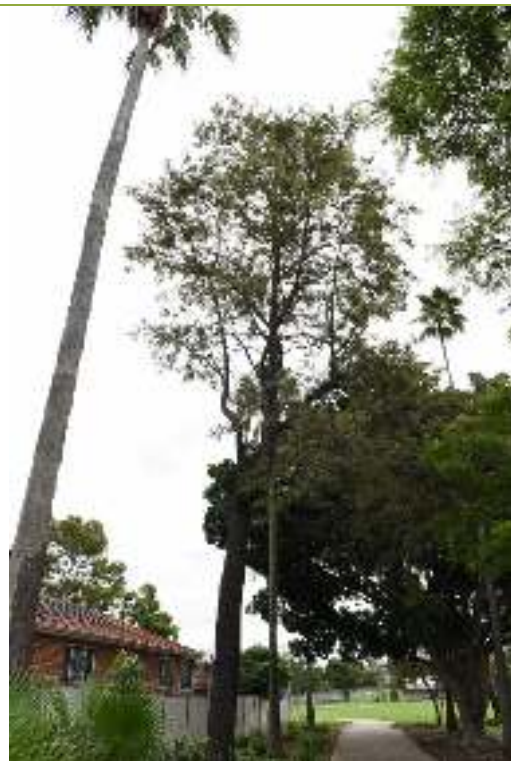
View of established trees lining footpaths throughout Colquhoun park.

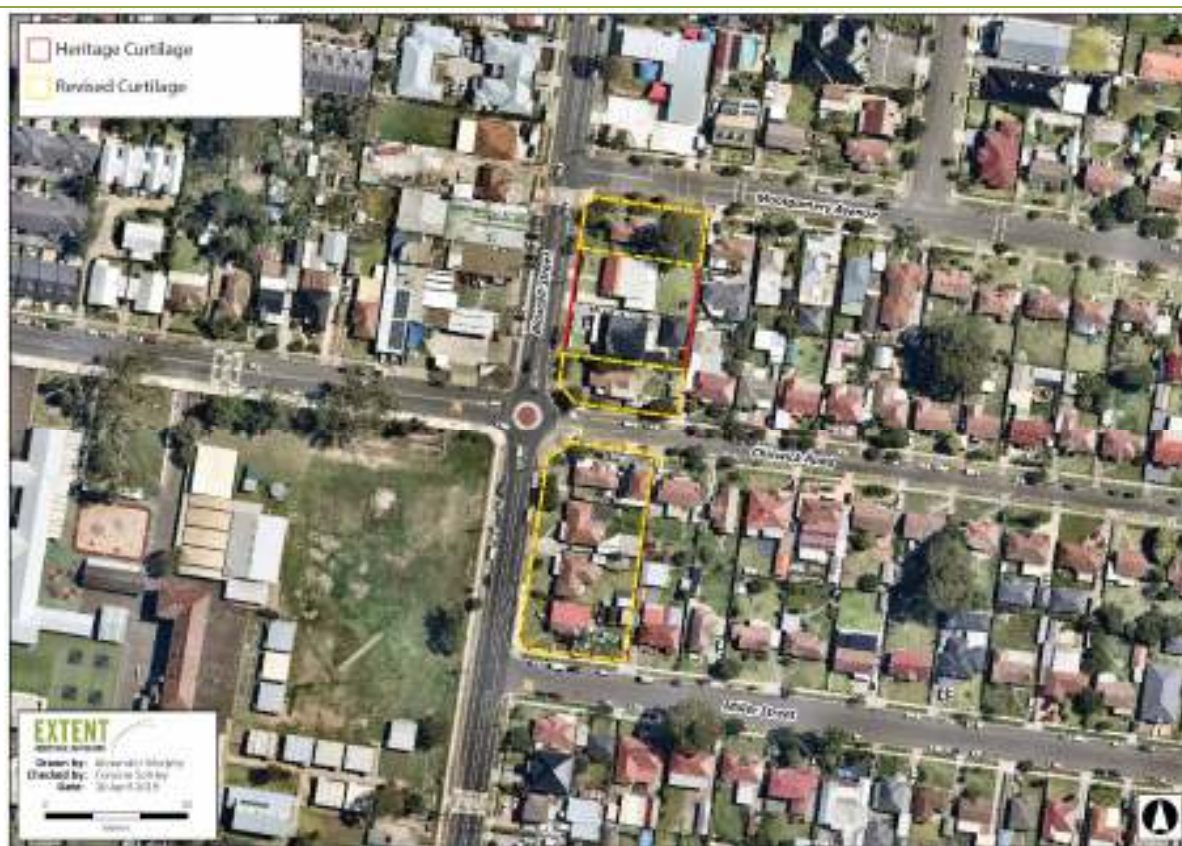
- Due to a range of modern alterations and additions, the dwellings at 349 and 351 Blaxcell Street have low heritage integrity. While they can continue to contribute to the overall significance of the Blaxcell Estate Conservation Area, their inclusion as part of an individual heritage item is no longer warranted due to the extensive changes to both places on the façades, to the landscapes and to the rears. Therefore, the heritage curtilage shown below should be considered as a revised curtilage for the 'Houses built for Housing Commission' on Blaxcell Street in the Cumberland LEP. The dwellings at 349 and 351 Blaxcell Street should continue to be managed as part of the conservation area. Should the revised curtilage be adopted, this listing sheet does not reflect the current Lot/DP which will need to be altered.

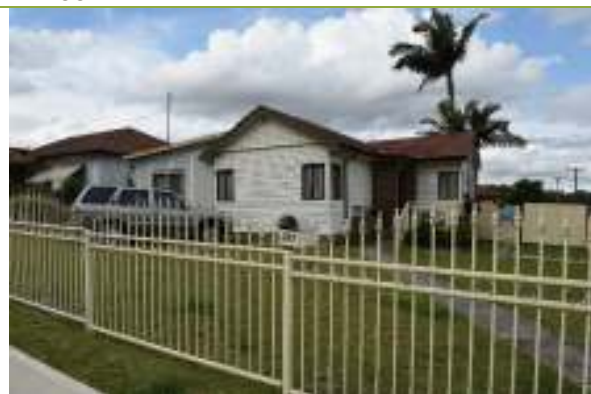
No. 361 Blaxcell Street

- The fibro extension to 361 Blaxcell Street is visible from Blaxcell Street and is considered to be a highly intrusive addition which reduces the overall significance of the dwelling and group of dwellings in general. Should the opportunity arise, this should be removed, and a sympathetic addition provided in its place.

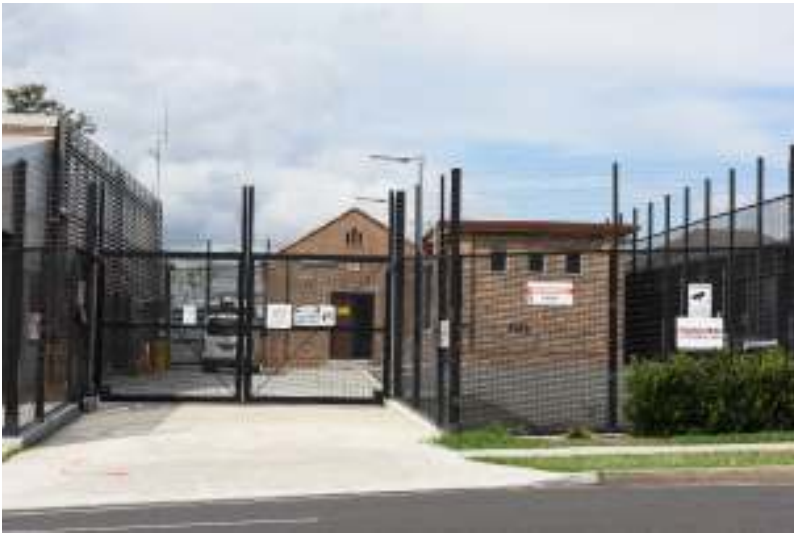
The electrical substation is still in operation. The brickwork and terracotta tiling all appear to be in very good condition. The item is in good condition.

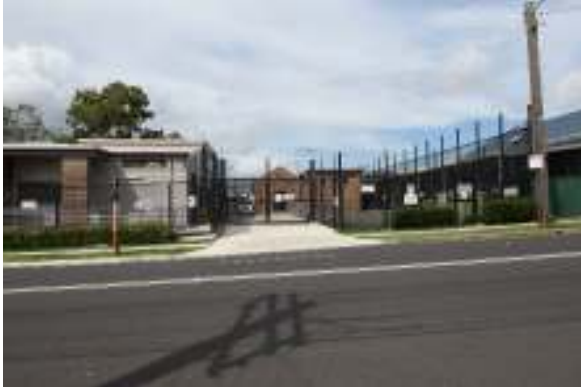
View from Blaxcell Street to Electricity Substation

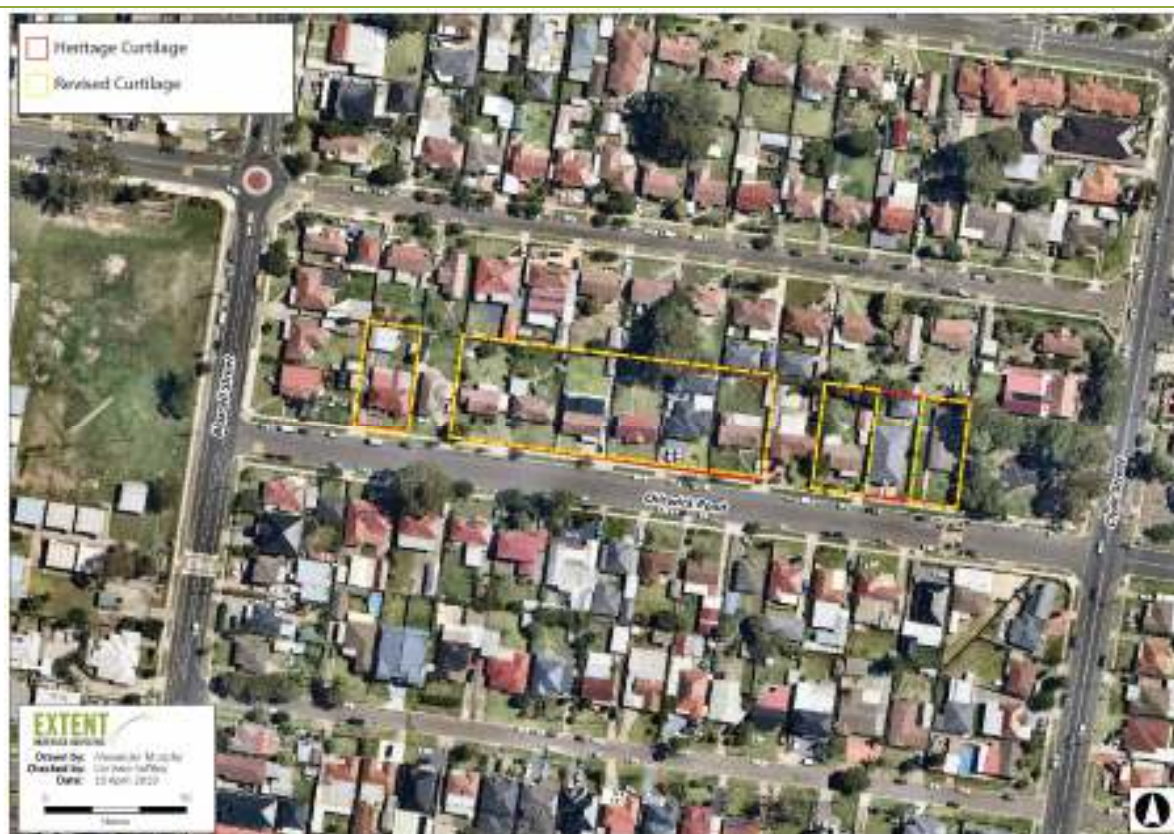
- A new dwelling has been constructed at 27 Chiswick Road, adjacent to an original but highly modified Housing Commission dwelling. The heritage curtilage shown below should be considered as a revised curtilage for the Cumberland LEP. Should the revised curtilage be adopted, this listing sheet does not reflect the current Lot/DP which will need to be altered.

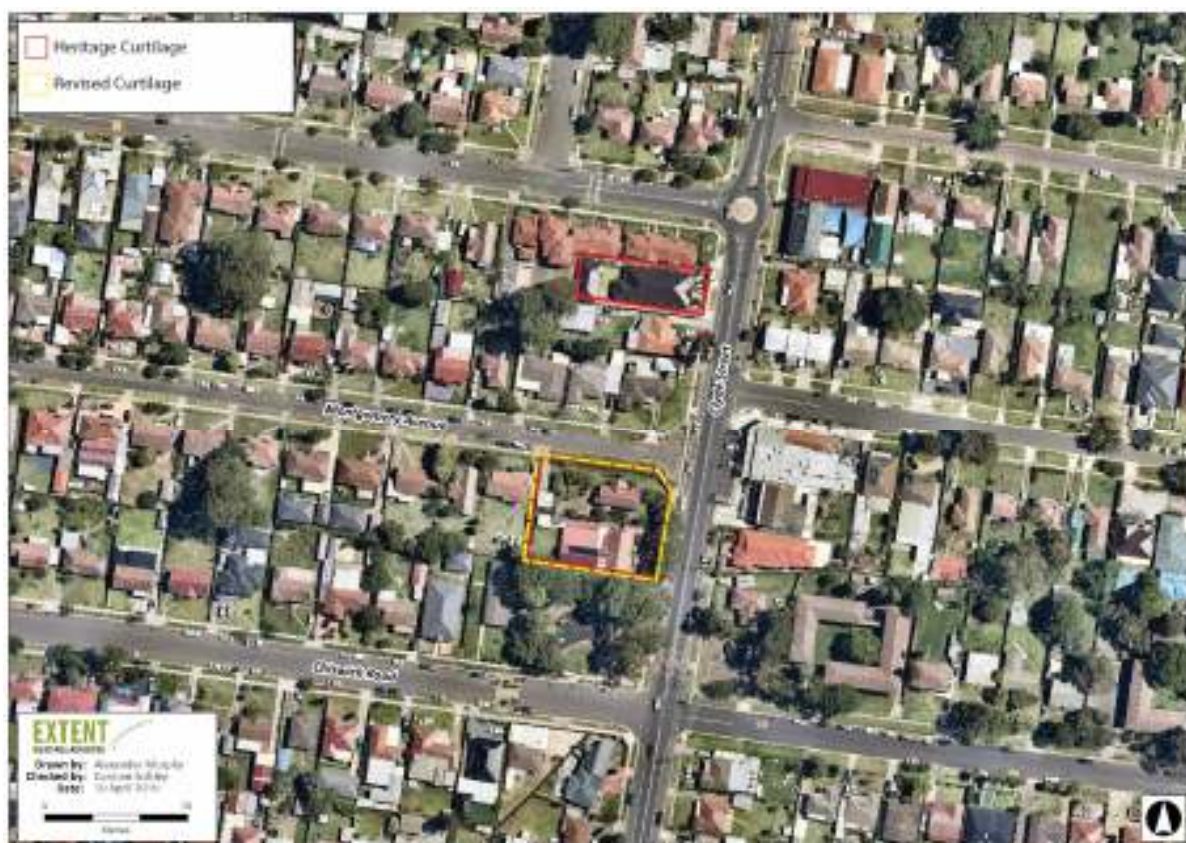
- The original dwelling at 278 Clyde Street has been demolished and replaced and the new build has no heritage significance. The heritage curtilage shown below should be considered as a revised curtilage for the 'Houses built for Housing Commission' on Clyde Street in the Cumberland LEP. Should the revised curtilage be adopted, this listing sheet does not reflect the current Lot/DP which will need to be altered.

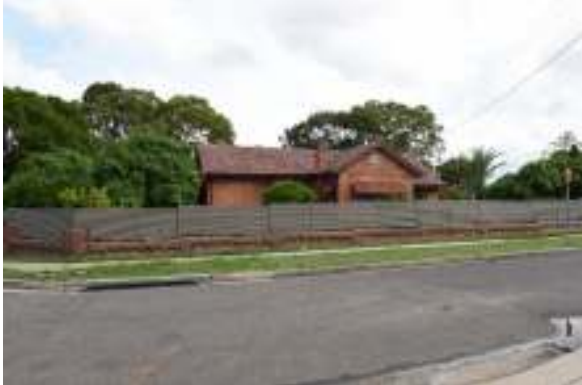
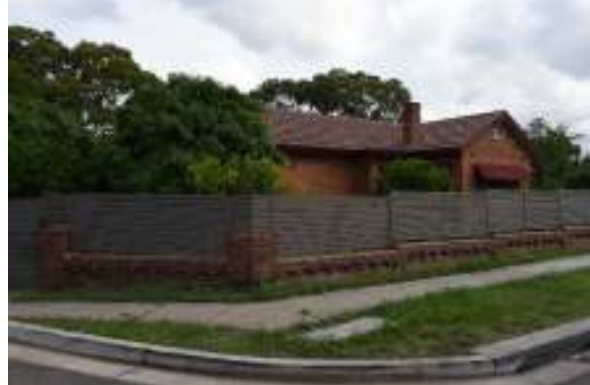
No. 286 Clyde Street.

Overall, the two dwellings are well maintained, and their condition is good.

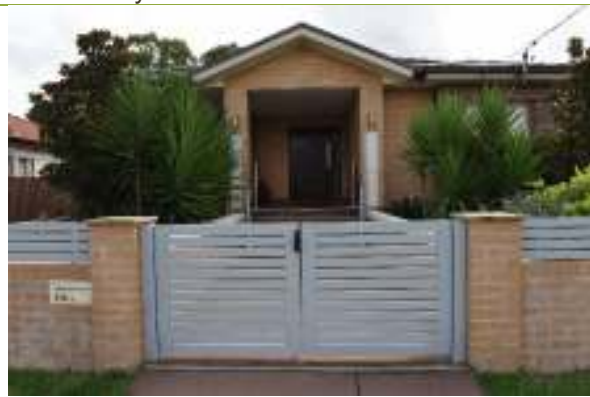
The original dwelling at 278 Clyde Street has been demolished and replaced with a modern dwelling. The new dwelling built c. 2014 is not a heritage item and should be removed from the listing.

New dwelling at 278 Clyde Street.

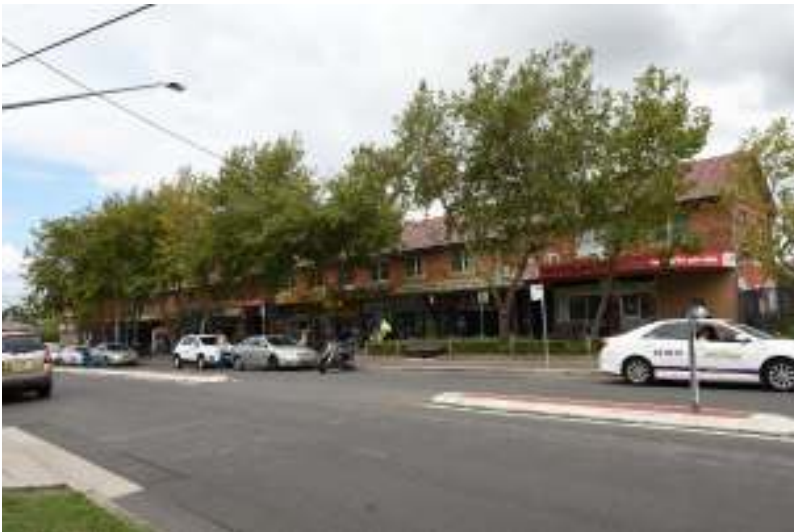
The item is a Post-War (c. late-1940s) two-storey brick-veneer building with a shopping strip on the ground floor and apartment-style residences above. The building exterior features decorative banded brick walls with a gabled terracotta tile roof. The main long building is intersected at the western end by a gable-ended L-shaped wing. There is a flat cantilevered awning running the length of the main building. There is a mix of original and modern elements along the façade fenestration, including modern aluminium infill windows, window grilles, air conditioning units, signage and steel roller shutters. Signage on the awnings and glazed shopfronts have been provided directly onto the brickwork, detract from the significance of the building.

The item appears to be in fair condition, with a number of later additions and alterations.

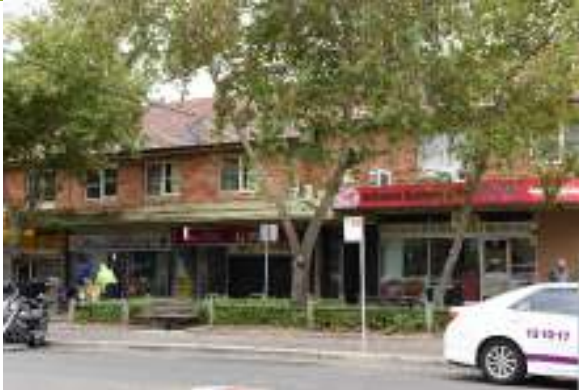
View of shopfronts from Dellwood Street.

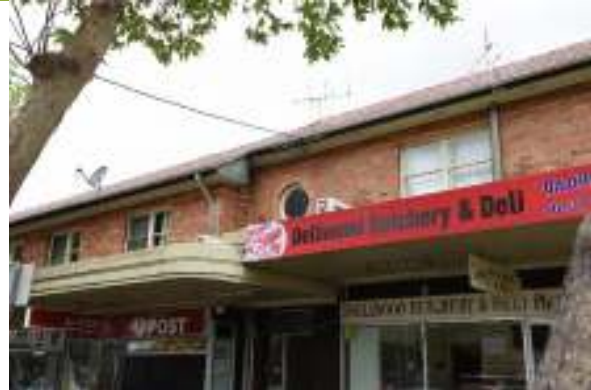
- Modern elements including modern aluminium infill windows, window grilles, air conditioning units, signage and steel roller shutters*.
- Signage on the awnings, glazed shopfronts and directly onto the brickwork*.
- Structures enclosing the yards in the rear of the building

Detail of the awnings along the north elevation.

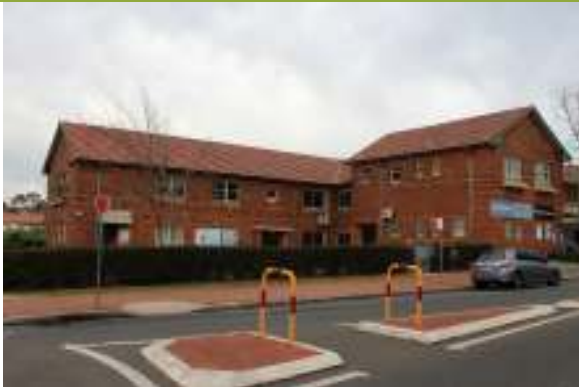
View from the corner of Dellwood Street and Pegler Avenue.

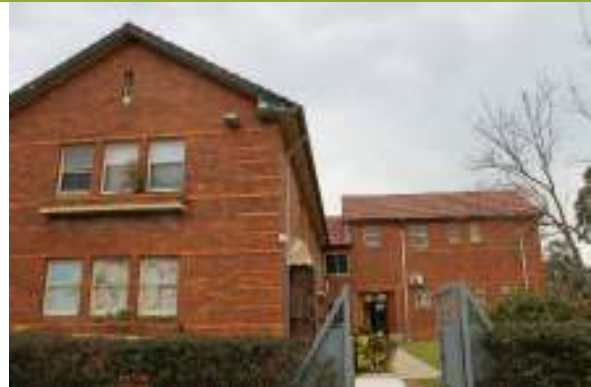
View of east elevation from Pegler Avenue.

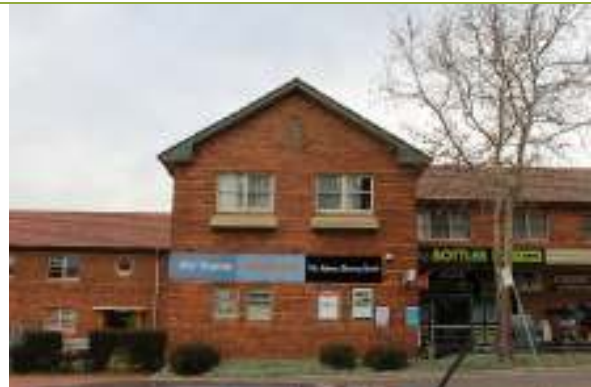
Detail of north elevation from Dellwood Street.

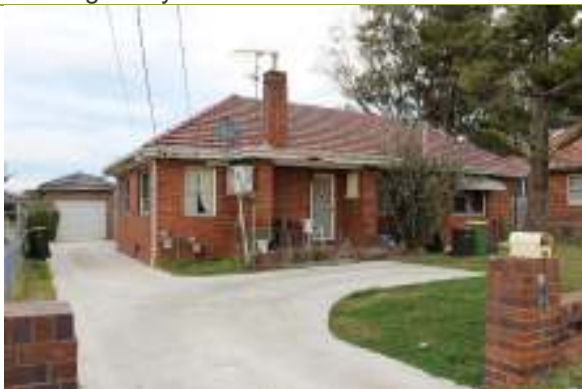
10 Montgomery Avenue.

The condition of the building is good overall, however has a deteriorated timber fascia.

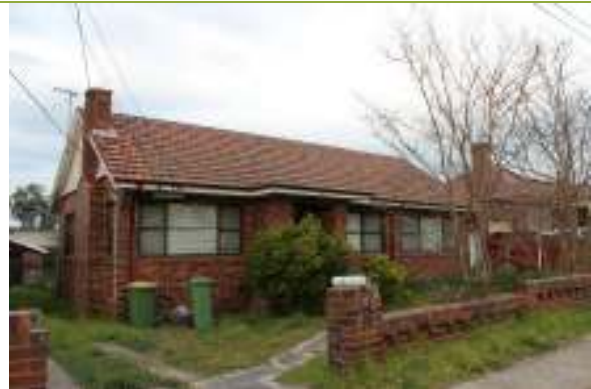
16 Montgomery Avenue.

The condition of the building is good overall, although some paint is peeling from the gable end.

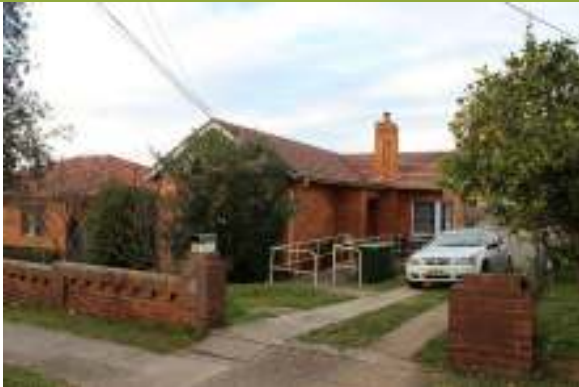
22 Montgomery Avenue.

The condition of the building is good overall, although there is paint peeling from weatherboards at the gable ends.

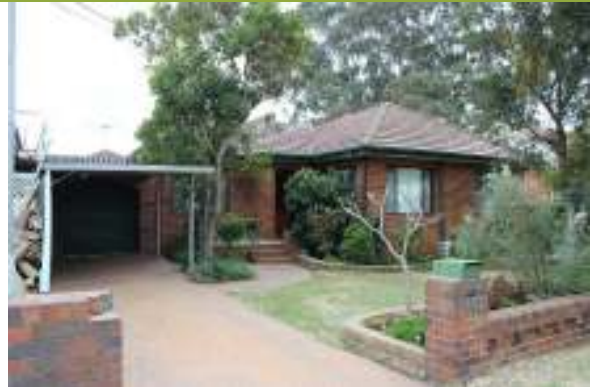
21 Montgomery Avenue.

Some dwellings retain their original timber framed sash windows with brick window boxes. The windows of 21 Montgomery Avenue have been replaced with aluminium slide windows.

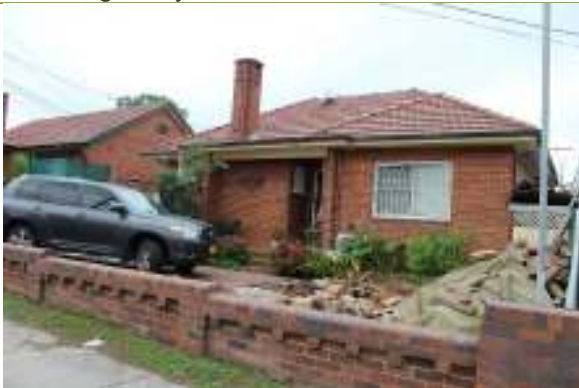
23 Montgomery Avenue.

The condition of the building is good overall, although there is scattered debris in the front yard that impact on the visual aesthetic of the property.

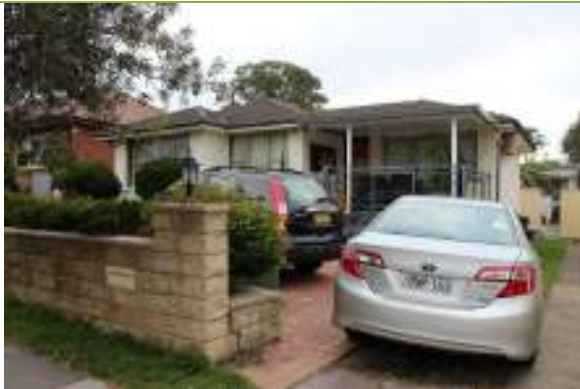
27 Montgomery Avenue.

The dwelling at 27 Montgomery Avenue is a later dwelling that is similar in scale although not form to the earlier dwellings on Montgomery Street. The residence is rendered brick, triple fronted with a hip and valley roof clad in grey Marseilles tiles and a new guttering. A thin metal chimney sits on the western side of the dwelling towards the rear. The front façade features a wide verandah with a flat modern metal roof supported by square metal verandah posts and surrounded by a glass and steel balustrade. The verandah is accessed by a set of stairs the foundations are clad in faux stacked stone. The dwelling has large aluminium-framed modern sliding and sash windows to all elevations.

The condition of the building is good overall, although there is some loss of mortar to the sandstone block boundary fence.

- Due to a range of modern alterations and additions, the dwelling 27 Montgomery Avenue has low heritage integrity. While it can continue to contribute to the overall significance of the Blaxcell Estate Conservation Area, its inclusion as part of an individual heritage item is no longer warranted due to the extensive changes to façade, landscapes and rear. Therefore, the heritage curtilage shown below should be considered as a revised curtilage for the 'Houses built for Housing Commission' on Montgomery in the Cumberland LEP. The dwellings 27 Montgomery Avenue should continue to be managed as part of the conservation area. Should the revised curtilage be adopted, this listing sheet does not reflect the current Lot/DP which will need to be altered.

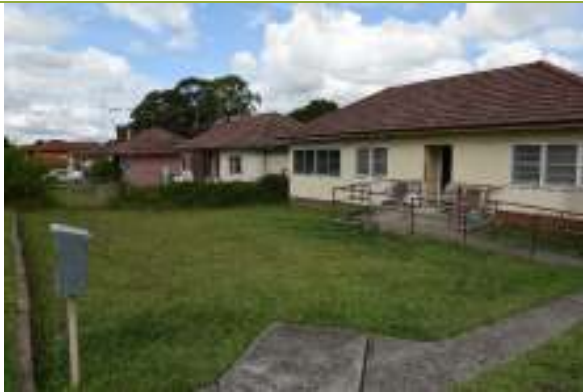
No. 10 and 12 Oakleigh Avenue.

The dwelling has fibro walls and a cement-tiled gable roof. The roof features modern guttering. Unlike the other dwellings along Oakleigh Avenue, the dwelling at 12 Oakleigh Avenue does not appear to have a chimney. Windows are rectangular and aluminium framed, with flyscreens installed. The exterior window architrave is timber. The front entrance is constructed in the centre of the façade. The porch steps have been removed and replaced with a concrete ramp and guardrail, and an aluminium handle has been installed within the porch wall. The fibro dwelling sits on brick footings.

- A number of houses within this listing require minor conservation repairs. They include:
 - ♦ 10 Oakleigh Avenue – Brickwork to the base of the front porch require repointing.
 - ♦ 26 Oakleigh Avenue – Brickwork to the base of the front porch requires repointing and replacement.
 - ♦ 6 and 8 Oakleigh Avenue – repair chimney flashings.
