## Heritage Inventory Sheet

<b>Item Name</b>	St Enda's Church Hall, (inter-war hall, circa 1929)		
<b>Recommended Name</b>	St Enda's Church Hall		
<b>Site Image</b>

<b>Item Name</b>	Toongabbie Railway Station Group, Underbridge & Archaeological Remains		
<b>Site Image</b>

<b>Item Name</b>	Portico Park		
<b>Recommended Name</b>	Portico Park		
<b>Site Image</b>

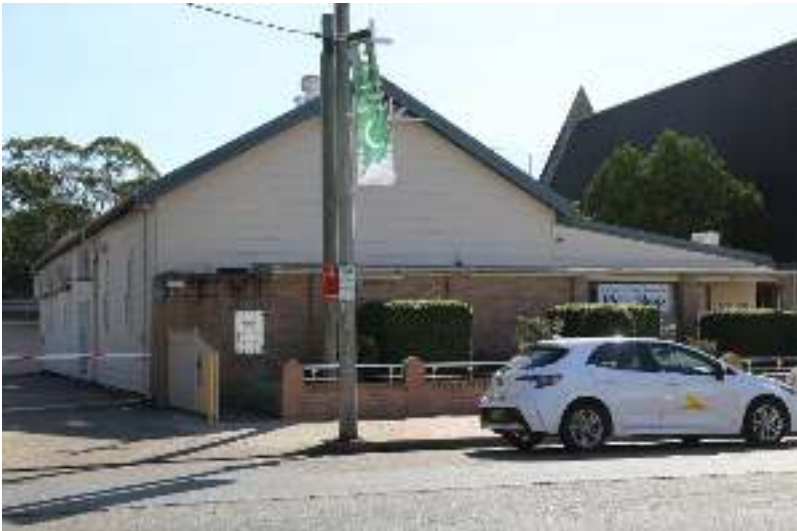
The site contains a single storey timber framed church hall dating from the Inter-War period. Forming part of the St Anthony's Roman Catholic Church complex, it is presently used by several parish and community groups.

The building has a single gable roof of corrugated steel and exposed rafters. The gable end to the street features decorative timber barge boards and cross elements. The roof has several whirly birds along the roof ridge, a simple barge board to the gable end and modern roof guttering and downpipes. All original wall cladding appears to have been replaced, with weatherboards to the western side and rear, and profiled hardiplank to the front. A series of five timber framed double hung windows on the western side remain intact.

A skillion addition extends along the entire eastern side of the building, which appears to have been constructed in several stages. It has weatherboard cladding to waist height, battened fibro above and aluminium sliding windows.

A face brick toilet block and portico has been added at the front, with entry through a single door skillion addition. The roof is corrugated sheet metal. The addition contains some 'Piety Shop' signage and a utilities box.

The hall is in fair condition overall. It appears the bargeboard and guttering has been replaced in the recent past, the brick extension demonstrates poor drainage with the presence of biological growth along the upper courses of brickwork.

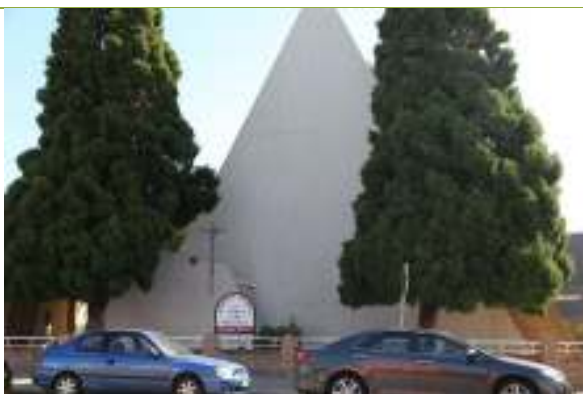
Detail of tiled façade of Church.

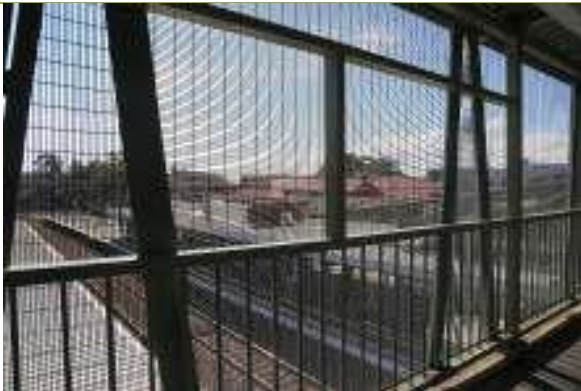
*External: The building on Platform 1/2 is larger than Platform 3/4 building and is a post war Functionalist style railway building. It is of face brick construction with low pitched gabled roof and brick parapets at each end with courses of recessed heeler bricks capped by a course of bullnosed bricks. The northern end of the building is defined by a curved masonry bay with a single door. Centrally located on each parapet is an Art Deco style projecting vertical masonry fin constructed of heeler bricks in a contrasting*

View northeast from concourse to Platform 1/2.

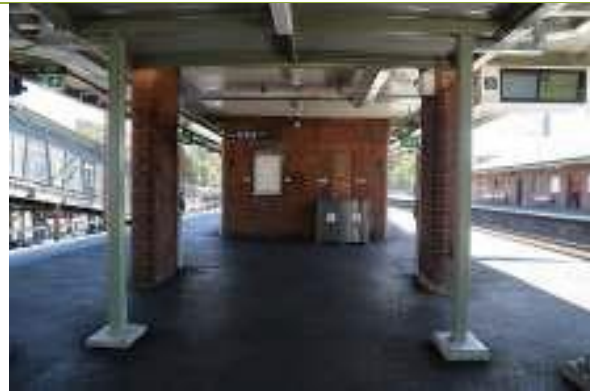
*External:* The station building on Platform 3/4 is approximately half the size of the Platform 1/2 building featuring the same detailing and architectural style with the exception of the curved bay on one end. It is of face brick construction with low pitched gabled roof and brick parapets at each end with courses of recessed heeler bricks capped by a course of bullnosed bricks. Centrally located on each parapet is an Art Deco style projecting vertical masonry fin constructed of heeler bricks in a contrasting colour. The parapets step down on each side from the fin. The roof is clad with Colorbond which extends as an awning on all four sides of the building. The awning on the southern end, which provides shelter to passengers purchasing tickets from the ticket machine, is supported by two rectangular brick columns with curved corners. The building has one ticket window, unlike Pendle Hill (and formerly Westmead) which had two. Early timber doors are extant. The standard steel framed windows with three horizontal hopper panels (central panel fixed) are vertically proportioned and placed regularly on both platform elevations between the solid timber doors. A contemporary canopy connects the building from the underside of the original awning to the stairs and footbridge.

View north to Station Building on Platform 3/4.

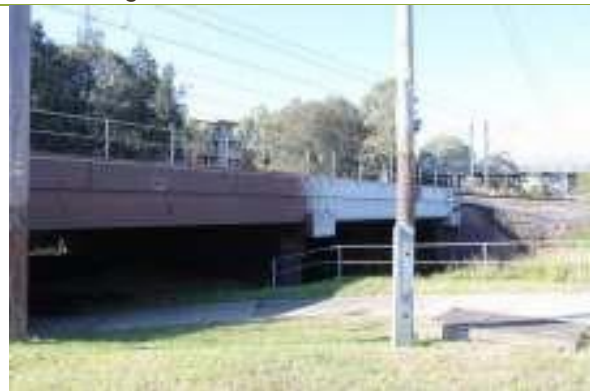
View east to Underbridge from Portico Parade

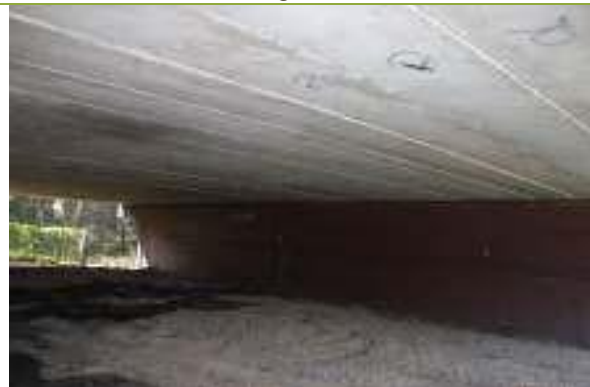
The archaeological potential for the remains below the underbridge is likely to be high as there is no evidence that suggests they have been removed, rather than simply overgrown.

View south under contemporary underbridge, to location of archaeological remains

- Any proposed ground disturbance work should be assessed by a qualified historical archaeologist for archaeological potential and heritage impact mitigation.

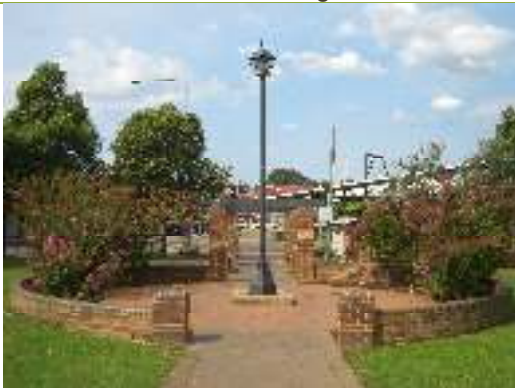
View to centre brick retaining wall, looking northeast.
