## Heritage Inventory Sheet

<b>Item Name</b>	Prospect Reservoir and Surrounding Area		
<b>Recommended Name</b>	Prospect Reservoir and Surrounding Area (part only)		
<b>Site Image</b>	No image available of the curtilage related specifically to Cumberland.

## Curtilage Map

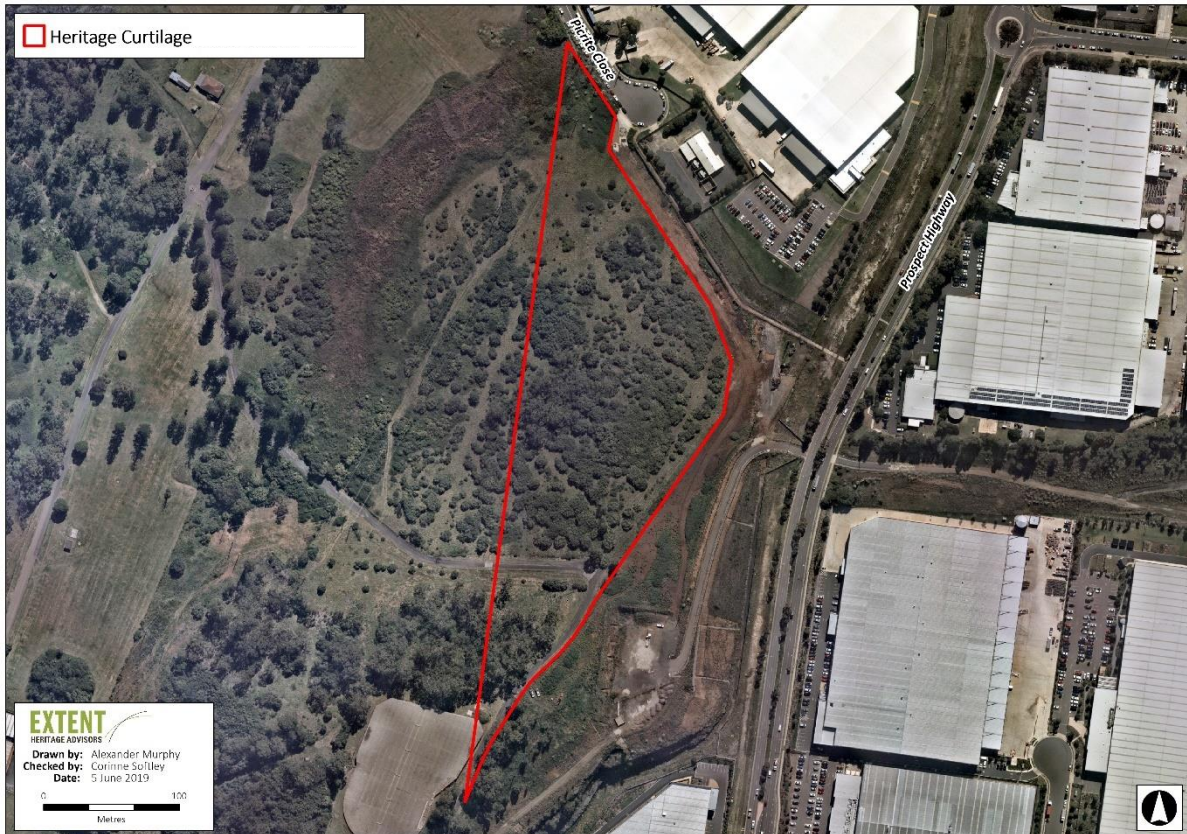
The Cumberland Council LGA includes one small portion of the whole Prospect Reservoir State Heritage Register item.

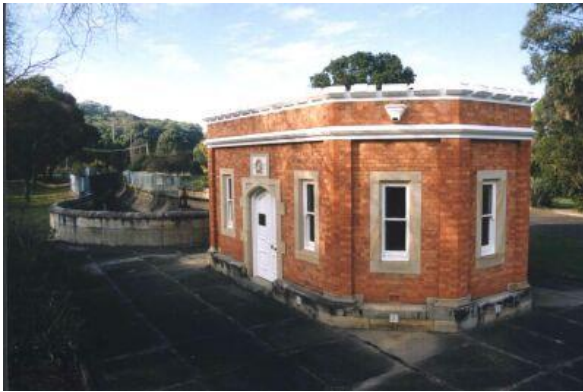
Lower Valve House and Receiving Basin on the Lower Canal (Source: NSW Office of Environment and Heritage, State Heritage Register listing sheet for Prospect Reservoir)

The Lower Valve House is similar in style to the Outlet Tower and originally controlled water entering the Lower Canal. The Lower Canal was decommissioned in the 1980s, but the original equipment in the Lower Valve House remains largely intact. The tunnel extends a short distance beyond the Lower Valve House.

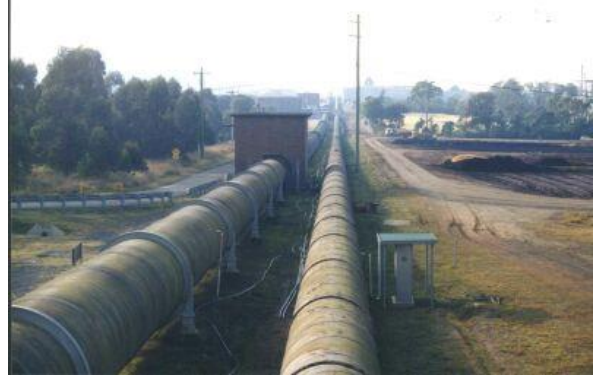
Pipelines (Source: NSW Office of Environment and Heritage, State Heritage Register listing sheet for Prospect Reservoir)

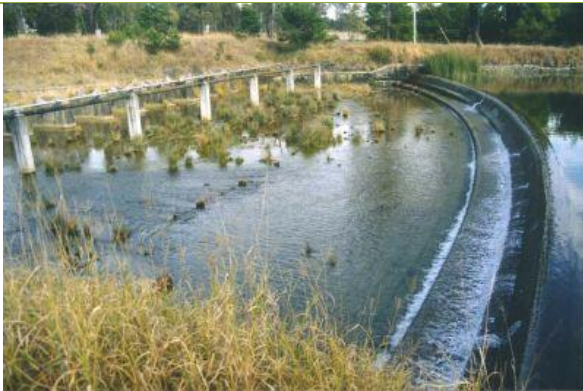
By-Wash Channel (Source: NSW Office of Environment and Heritage, State Heritage Register listing sheet for Prospect Reservoir)

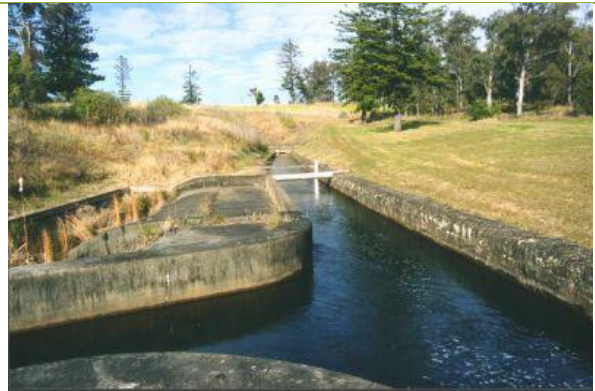
Upper Canal near its entry to Prospect Reservoir (Source: NSW Office of Environment and Heritage, State Heritage Register listing sheet for Prospect Reservoir)
