Heritage Inventory Sheet

Item Name	Commercial Building		
Recommended Name	Commercial Building		
Site Image	 		
Address	20 Amy Street, Regents Park NSW 2143		
Lot/Section/DP	11	-	12804
Draft Cumberland LEP ID	I232		
Former LEP ID	I43 (Auburn LEP)		
Heritage Conservation Area	Not included		
Date Updated	March 2020		
Significance Level	LOCAL		
Site Type	Level 1	Built	
	Level 2	Commercial

Item Name	Regents Park Railway Station Group		
Recommended Name	Regents Park Railway Station Group		
Site Image

Address	Park Road, Regents Park NSW 2143		
Lot/Section/DP	31	-	1221455
Draft Cumberland LEP ID	I233		
Former LEP ID	I44 (Auburn LEP)		
Heritage Conservation Area	Not included		
Date Updated	March 2020		
Significance Level	LOCAL		
Site Type	Level 1	Built	
	Level 2	Transport – Rail

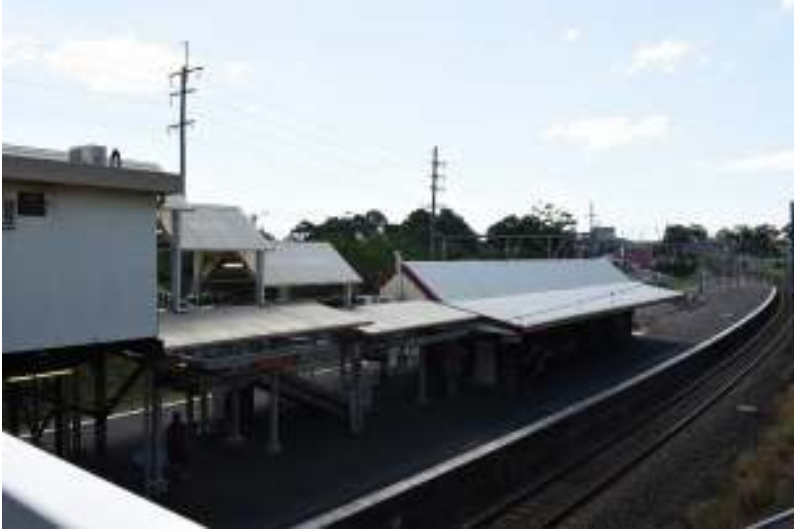
Regents Park Railway Station is accessed from the west from the junction of Rose Street, Carlingford Street and Park Road and from the east from Auburn Road and Amy Street. It has one island platform, a footbridge and a building on the platform which incorporates the booking office. There are commercial strips on either side of the station.

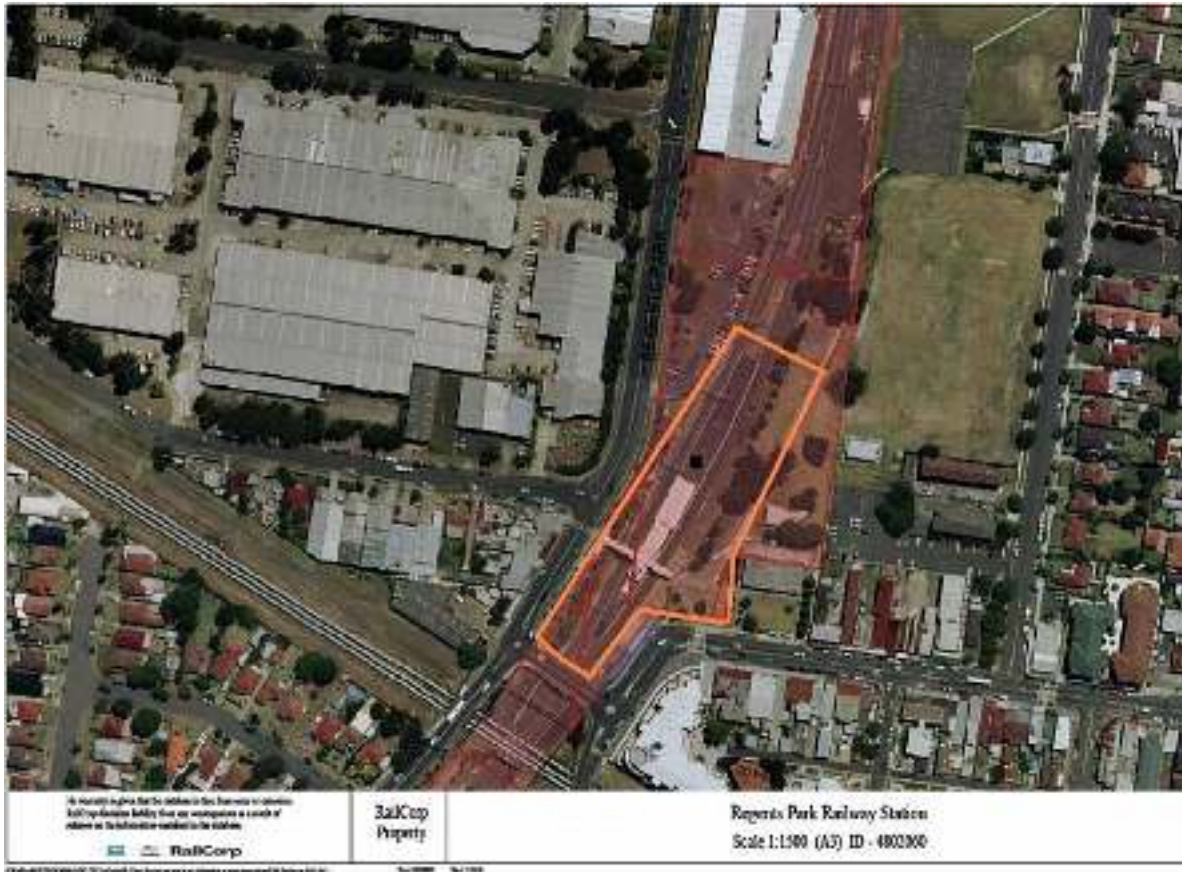
- The heritage curtilage should be revised to match the RailCorp Section 170 Heritage and Conservation Register curtilage for the station; see item #4802060 and plan below. Should the

revised curtilage be adopted, this listing sheet does not reflect the current Lot/DP which will need to be altered.

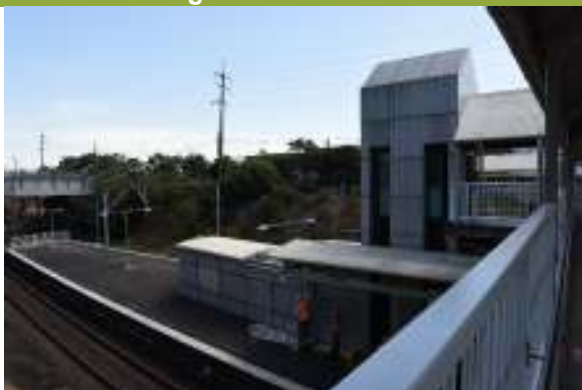
Platform footbridge and modern lift.

The footbridge comprises of a bridge connecting either sides of the station, a set of stairs that lead down to the platform, entrance canopies and a disabled access ramp from Carlingford Street. The entire structure rests on the original 1920s superstructure of steel columns, beams and trestles. The stairs and the deck are constructed of in-situ concrete and have painted steel handrails. There are a series of gable roof awnings made of Colorbond steel that cover the footbridge, the stairs, the entrances to the station and the ramp.

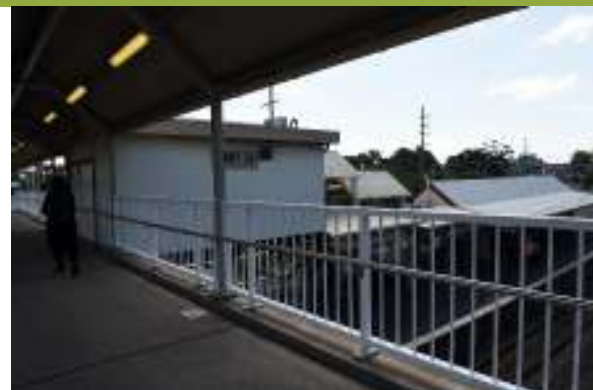
Platform footbridge.

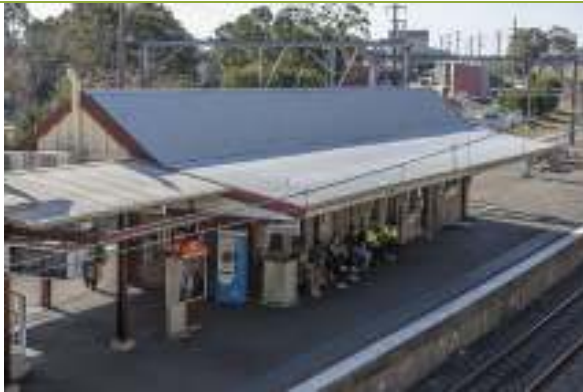
Platform building (Source: NSW Office of Environment and Heritage, Railcorp S170 Listing Sheet for Regents Park Railway Station Group).

External: Rectangular building six bays long with stretcher bond brickwork. The bays are defined by engaged brick piers that have decorative concrete corbels and standard steel double bowed brackets which support cantilevered awnings. The awnings which have curtain board fascia are integrated with the gable roof of the building and the roofing material for both the awning and the roof is corrugated steel. The roof has original timber finials.

The external walls rise from a projecting brick plinth with a decorative two part cement dado moulding which is continuous between door and window openings. Cement window and door frames rise from the dado moulding. Most of the door and window openings are original and the windows feature a decorative moulded cement sill. The original timber windows were double hung with a double paned lower sash and a multi-paned upper sash. This detail continued through in the fanlights above the doors. The doors were timber panelled. The northern end brick gable wall feature a louvre within a round brick window framed in voussoir shaped bricks, with four cement keystones. Some of the original windows have been retained with aluminium framed safety wire meshes fitted to their outer side. Others have been altered, some windows have been removed and openings have been bricked in, whereas other windows have been boarded up and fitted with steel grills and some have been fixed with opaque, safety wire mesh incorporated glass. All the doors have all been replaced with flat panelled timber doors, and some have additional steel grill gates fitted to the outer edge of the door opening. One of the doors has an original fanlight whereas others have been refitted with opaque, safety wire mesh incorporated glass and one has an air-conditioning unit fitted within it. The original door opening to the northern end of the building has been removed and replaced by two flat panelled timber doors. The upper part of the original cement door frame has been retained and a new continuous cement door frame bridging the two new doors has been inserted below it.

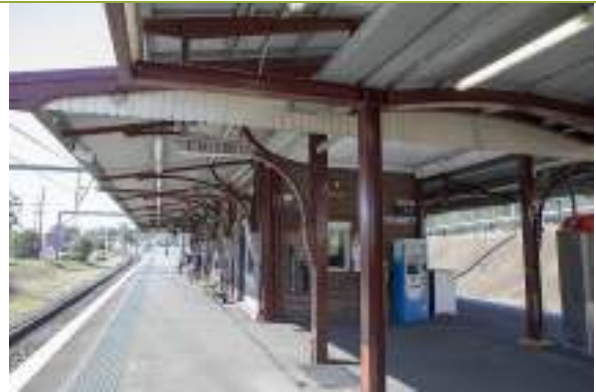
Underside of platform canopy (Source: NSW Office of Environment and Heritage, Railcorp S170 Listing Sheet for Regents Park Railway Station Group).

There is a modern canopy at the edge of the stairs that leads down from the footbridge onto the platform and it provides shelter to the space between the stairs and the booking office ticket window located on the south face of the original building. The canopy has three roof sections, with two skillion roofs on either sides of a curved roof and all the roofs are made of Colorbond steel resting on steel I beam and columns. A smaller version of this three section canopy covers the area between the footbridge and the lift.

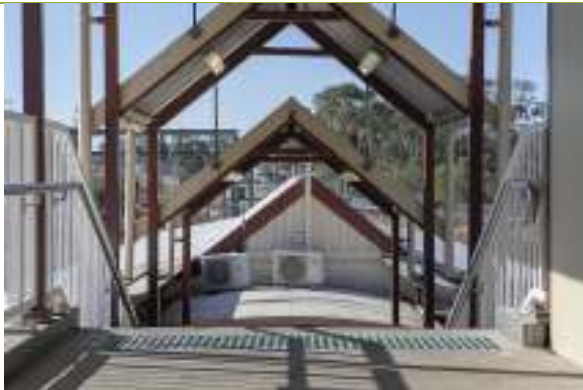
Platform canopy leading down to platform from footbridge (Source: NSW Office of Environment and Heritage, Railcorp S170 Listing Sheet for Regents Park Railway Station Group).

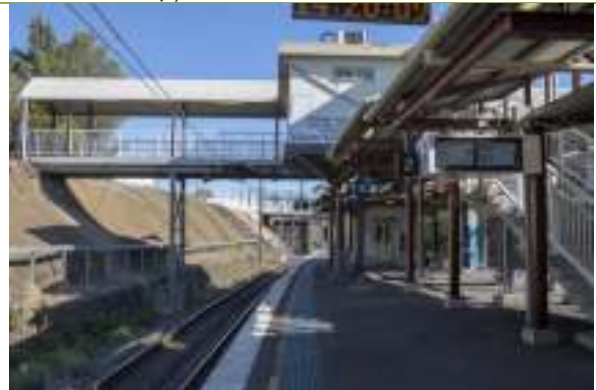
Footbridge (Source: NSW Office of Environment and Heritage, Railcorp S170 Listing Sheet for Regents Park Railway Station Group).
