Heritage Inventory Sheet

Item Name	St Enda's Church Hall, (inter-war hall, circa 1929)			
Recommended Name	St Enda's Church Hall			
Site Image				
				and walls are a final to the
Address	27-33 Aur	elia Street	t, Toongabbie NSW 2146	
Address Lot/Section/DP	27-33 Aur 42-45	elia Street	t, Toongabbie NSW 2146 C	10697
		elia Street		10697
Lot/Section/DP Draft Cumberland	42-45			10697
Lot/Section/DP Draft Cumberland LEP ID	42-45 I246	oyd LEP)		10697
Lot/Section/DP Draft Cumberland LEP ID Former LEP ID Heritage Conservation	42-45 I246 I101 (Holn	oyd LEP)		10697
Lot/Section/DP Draft Cumberland LEP ID Former LEP ID Heritage Conservation Area	42-45 I246 I101 (Holn	oyd LEP)		10697
Lot/Section/DP Draft Cumberland LEP ID Former LEP ID Heritage Conservation Area Date Updated	42-45 I246 I101 (Holn Not includ	oyd LEP)		10697

Item Name	'Toongabbi	'Toongabbie Railway Station' and 'Railway Viaduct'			
Recommended Name	Toongabbie Remains	Toongabbie Railway Station Group, Underbridge & Archaeological Remains			
Site Image					
Address	Portico Par	ade, To	ongabbie NSW 2146		
Lot/Section/DP	1		-	1016522	
Draft Cumberland LEP ID	A1 and I24	A1 and I247			
Former LEP ID	I102 (Holro	yd LEP)	'Toongabbie Ra

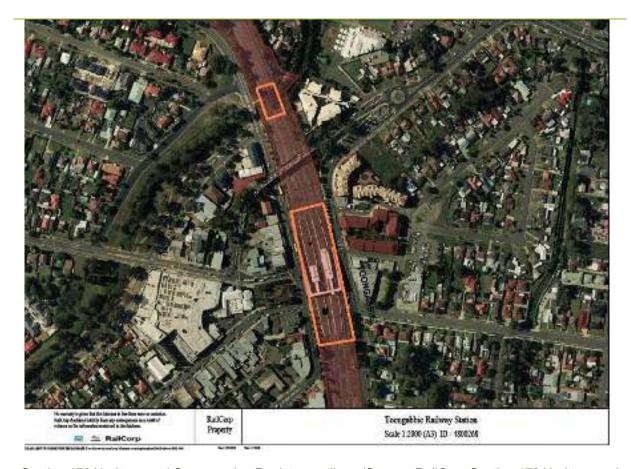
Section 170 Heritage and Conservation Register curtilage (Source: RailCorp Section 170 Heritage and Conservation Register curtilage for 'Toongabbie Railway Station Group, Underbridge & Archaeological Remains').
